## Arboriculturist Report

**RE:** Assessment of Trees on Victoria Avenue adjacent to Lot 37, Montario Quarter, Shenton Park

*Assessment of identified Trees on Victoria Avenue adjacent to Lot 37,  
Montario Quarter, Shenton Park*

July 12, 2018	Rev 0	Draft for Comment
July 24, 2018	Rev 1	FINAL
August 12, 2018	Rev 2	Up-Dated
August 23, 2018	Rev 3	FINAL

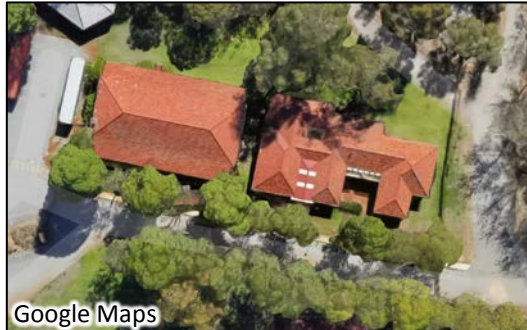
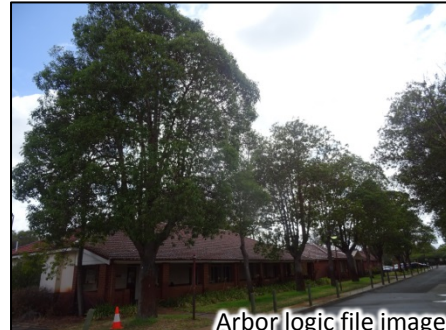
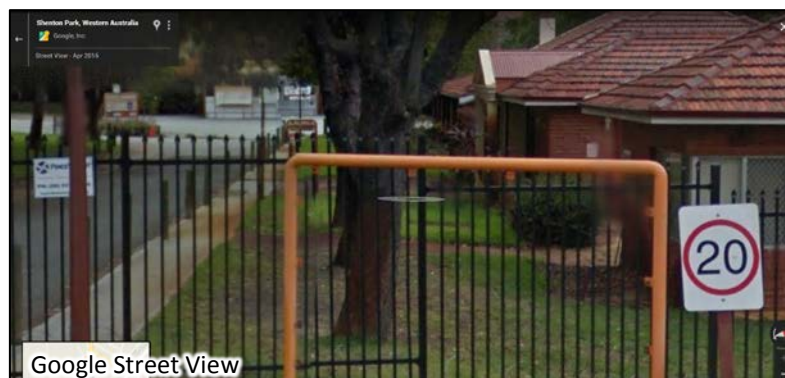
Previous buildings look to have been around 3 - 4 metres from the Trees (based on information available on Google Maps, Street View and images of the Site; see copies below).

Ground levels to the north of the Trees looks to have been lower than the levels at the base of their main stems. As such it is assumed that limited root mas from the Trees would have extended underneath the foundations of the previously existing buildings to their north.

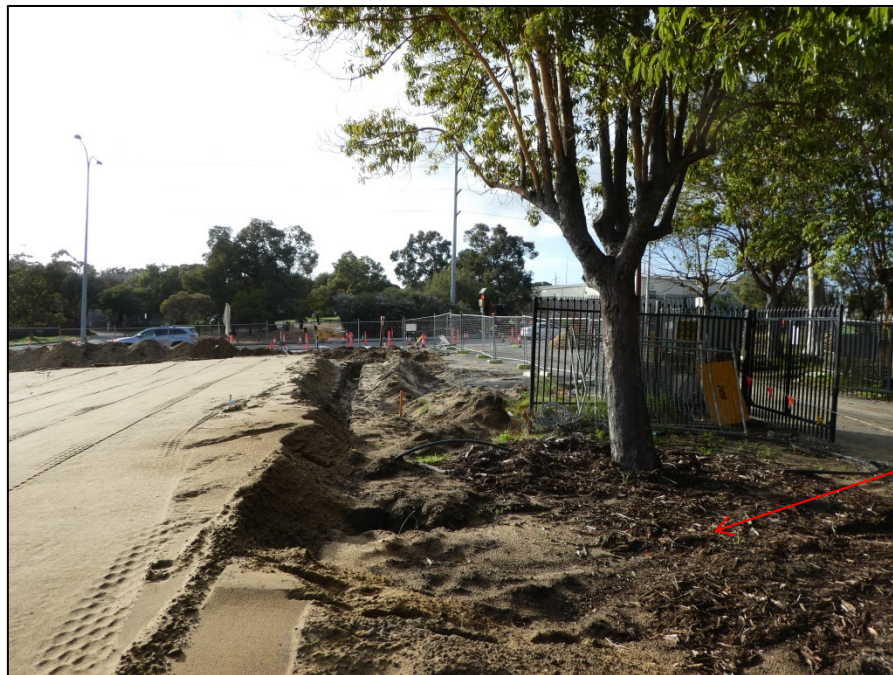
Original levels

Some extent of root zone disturbance looks to already have occurred around all Trees during Site clearing/demolition works.

Full extent of root disturbance and/or loss of root mass remains unknown and unable to be verified at this time. However it is assumed that clearing and some level of excavation has already occurred within part of the nominal TPZ of the Trees and possibly as close as 2-3 metres from their main stems.

A trench also looks to have been excavated between Trees #162 and #163. Disturbance was also noted to have occurred around 2 metres from the base of Tree #166.

Levels (within the Lot) now look to be currently higher than the original previous ground level.

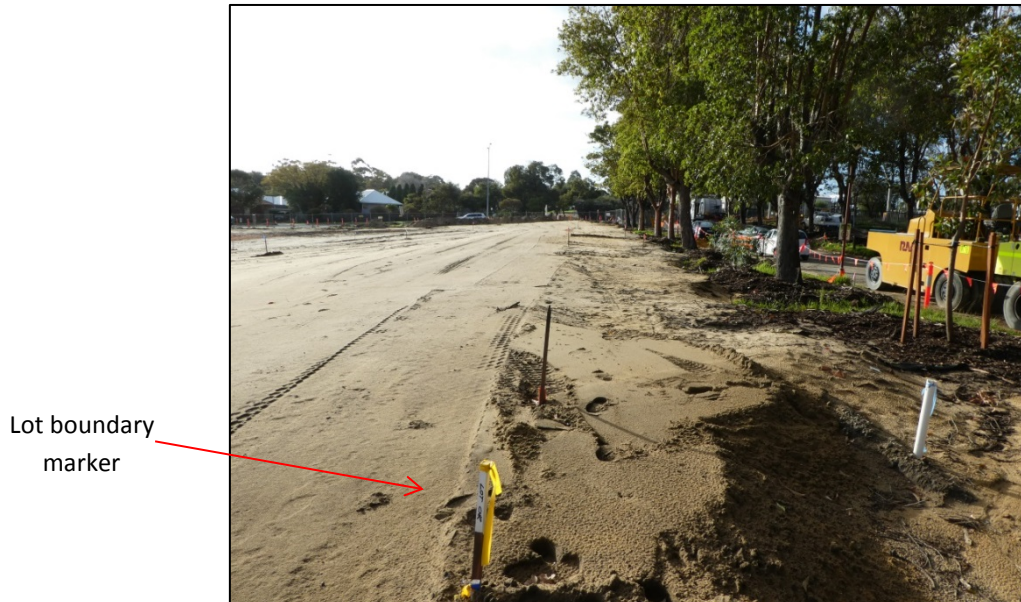
Lot boundary looks to be approximately 5 metres from the Trees.

Closest building on the Lot looks to be approximately 5 metres from the Trees; further away from the Trees than the previously existing buildings and in many respects outside of their likely root zone (modified TPZ) area.

Plan provided shows basement level to be constructed as part of the development, with closest point of basement 10.6 metres from Trees #166, #167 and #168. This is outside of the nominal TPZ of any of these Trees.

A 6 metres wide driveway is shown to be proposed to be installed between Trees #164 and #166. Driveway RL to be at verge level until Lot boundary before ramping up at 1:8.

This looks to encroach into the nominal TPZ of both of these Trees.

**7.3** Recommend to look to locate the driveway into the Lot from Victoria Avenue central to Trees #164 and #166 and undertake some further investigation to verify what level of root mas may be impacted by the extent of box-out required for its construction.

Arboricultural consultant is recommended to be on-site during box-out for driveway to undertake root pruning and provide further guidance as necessary.

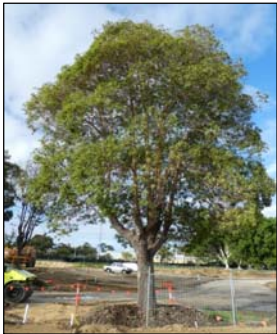
Tree Ref No	Species	Height (metres)	DBH (cm)	Canopy Spread (metres diameter)		Health	Structure	Image	Comment	Nominal TPZ (metres radius)
				N-S	E-W					
162	Queensland Box ( <i>Lophostemon confertus</i> )	15	62	8	9	Good	Acceptable

Continues to show reasonably good health based on the condition of its canopy. Excavation noted to have been undertaken to the west of the Tree at around 2m from the base of the Tree; within its nominal TPZ	7.44
163	Queensland Box ( <i>Lophostemon confertus</i> )	3	<10	1.5	1.5	Good	Good

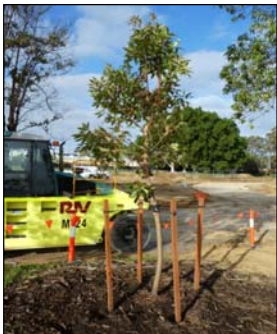
Juvenile tree and assumed to be a replacement for the previous tree. Good health/form and no issues noted	2
164	Queensland Box ( <i>Lophostemon confertus</i> )	14	50	7	8	Good	Acceptable

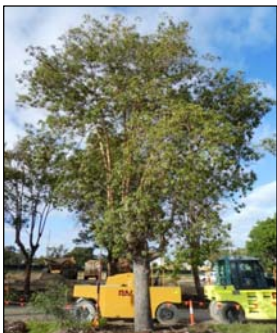
Continues to show reasonably good health based on the condition of its canopy, although uppermost canopy does look to be slightly sparse and possible early indications of decline	6
165	Queensland Box ( <i>Lophostemon confertus</i> )

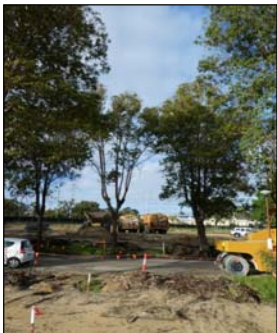
No tree present in this location; Looks to have been removed since the LandCorp arborist report was undertaken

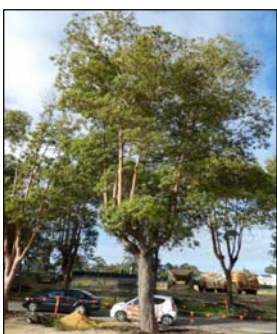
166	Queensland Box ( <i>Lophostemon confertus</i> )	15	60	9	9	Good	Acceptable

Continues to show reasonably good health based on the condition of its canopy. Some disturbance noted to have occurred within its nominal TPZ to the west of the Tree's main stem	7.2

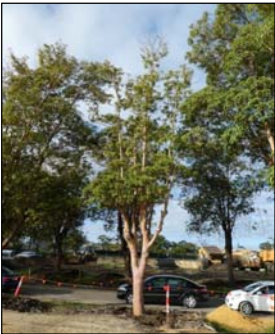
Tree Ref No	Species	Height (metres)	DBH (cm)	Canopy Spread (metres diameter)		Health	Structure	Image	Comment	Nominal TPZ (metres radius)
				N-S	E-W					
167	Queensland Box ( <i>Lophostemon confertus</i> )	12.5	33	4	4	Poor	Acceptable

Tree #167 looks to be in poor health and suggests that it may have limited life span remaining.

Canopy of this Tree is relatively sparse and apical sections of its canopy look to be dead. Remaining leaf mass is ok at this time, but volume is low	3.96
168	Queensland Box ( <i>Lophostemon confertus</i> )	14.5	40	5	7	Fair	Acceptable

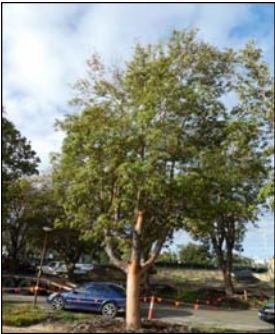
Shows ok health. Apical sections of its canopy do however look to be declining. Remaining lower-mid canopy area looks to be in reasonably good health at this time although volume does appear to be low for a specimen of this species at this size/age	4.8
169	Queensland Box ( <i>Lophostemon confertus</i> )	15	48	6	7	Fair	Acceptable

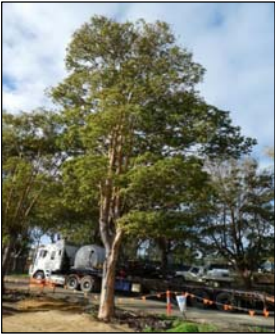
Shows ok health. Apical sections of its canopy do however look to be declining. Remaining lower-mid canopy area looks to be in reasonably good health at this time although volume does appear to be low for a specimen of this species at this size/age	5.76

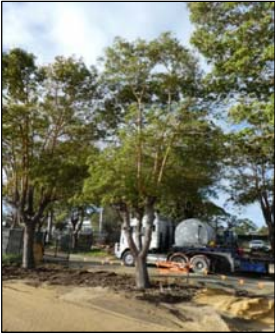
170	Queensland Box ( <i>Lophostemon confertus</i> )	12	42	7	5	Fair	Acceptable

Shows ok health. Apical sections of its canopy do however look to be declining. Remaining lower-mid canopy area looks to be in reasonably good health at this time although volume does appear to be low for a specimen of this species at this size/age	5.04
171	Queensland Box ( <i>Lophostemon confertus</i> )	12.5	44	8	7	Fair	Acceptable
