Port Hedland State School (fmr), 10 McKay Street, Port Hedland

Heritage Assessment and
Heritage Impact Statement

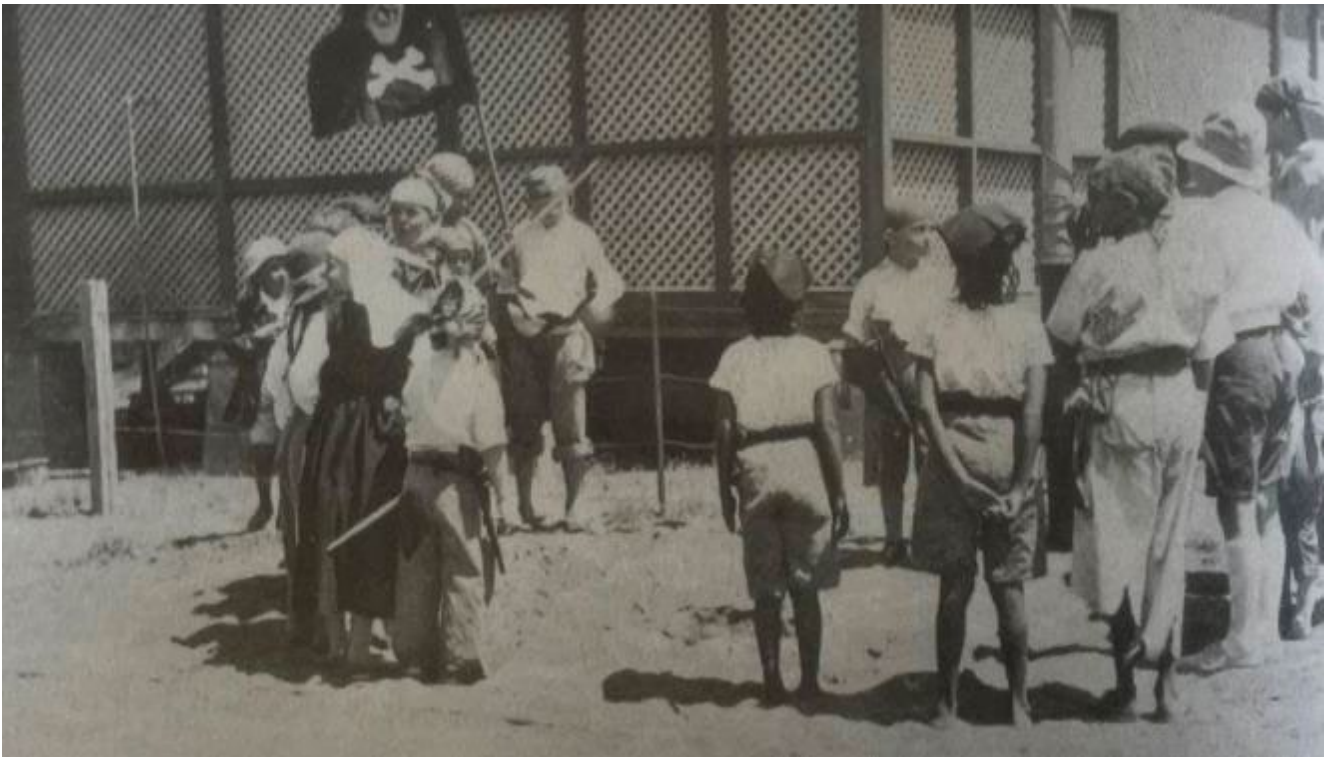
Figure 13 School play rehearsal with enclosed verandah, 1920s
Courtesy 'Through Dusty Eyes', p. 18.

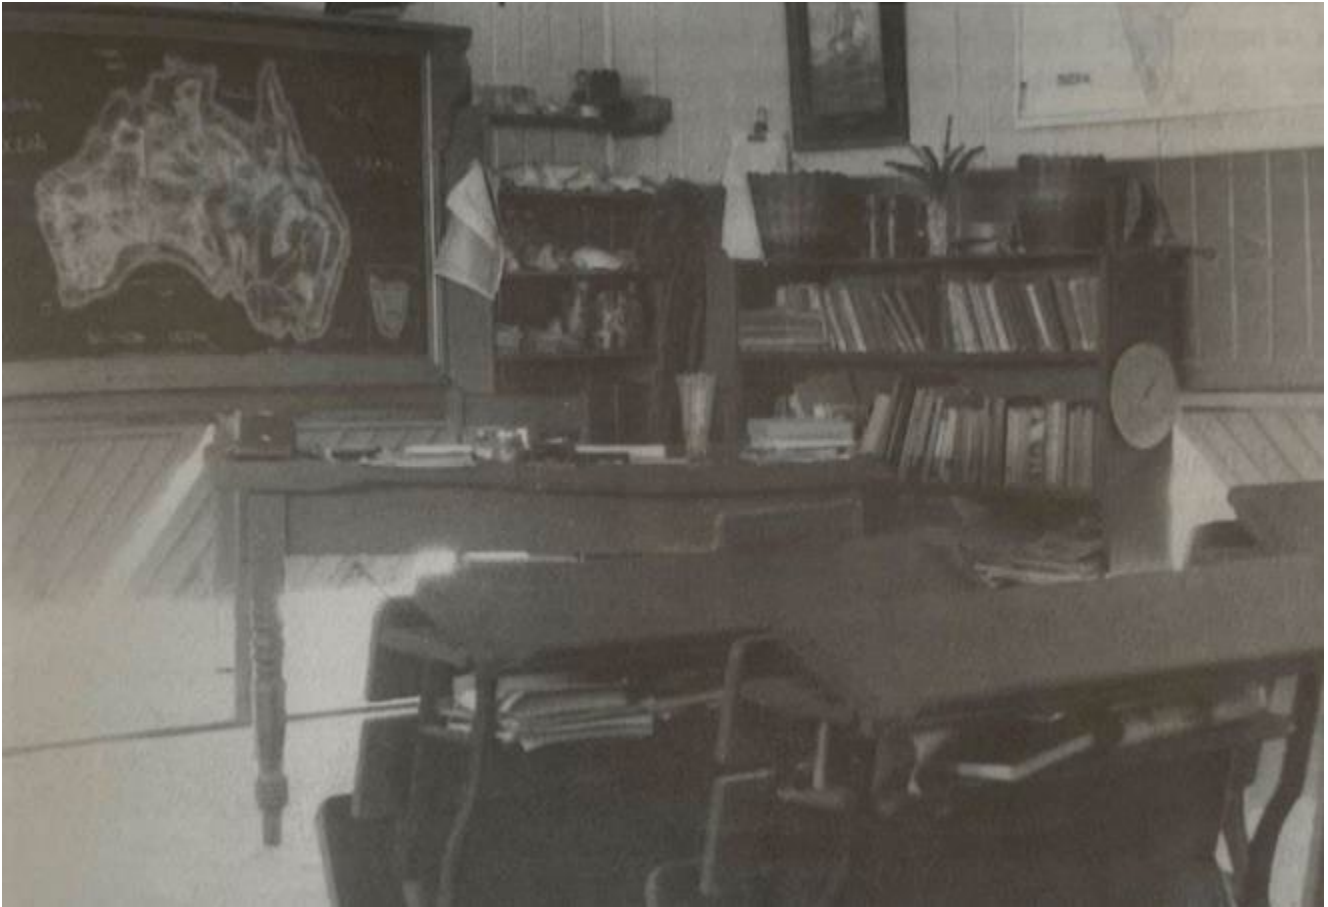
Figure 14 Interior of the Port Hedland School, 1947.
Courtesy 'Through Dusty Eyes', p. 30.

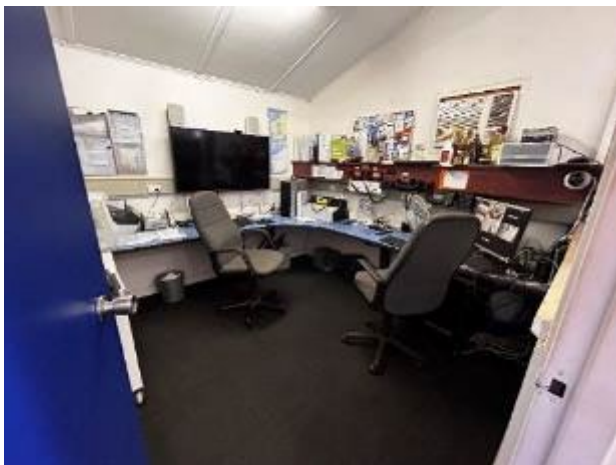
Figure 63: Radio Room

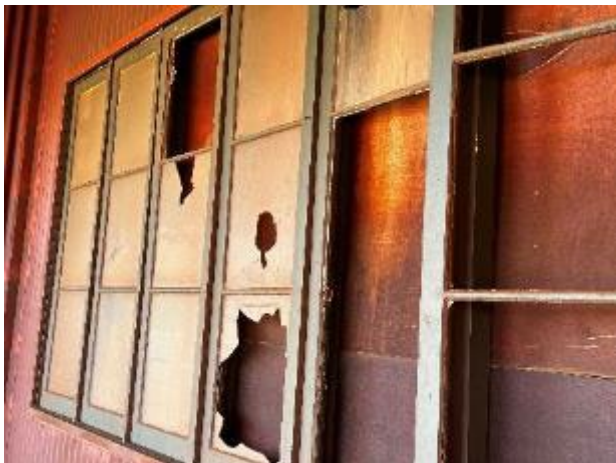
Figure 65: Broken glazing

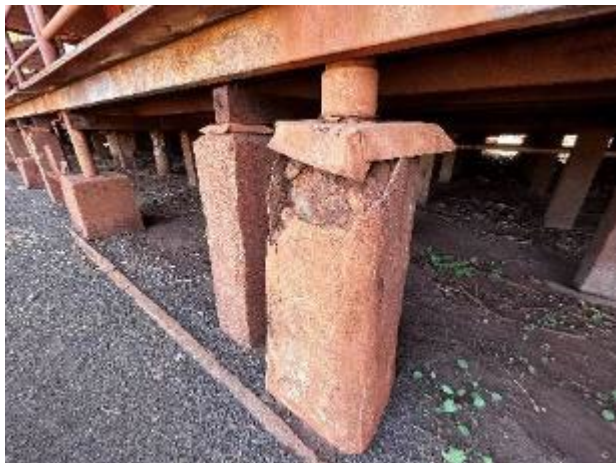
Figure 66: Typical concrete damage to stumps

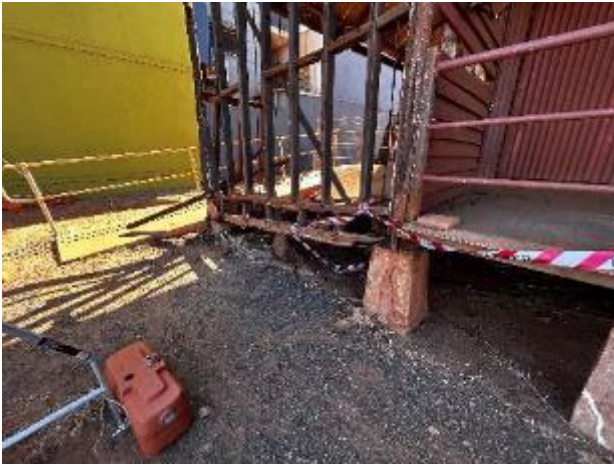
Figure 67: Collapsed northern verandah

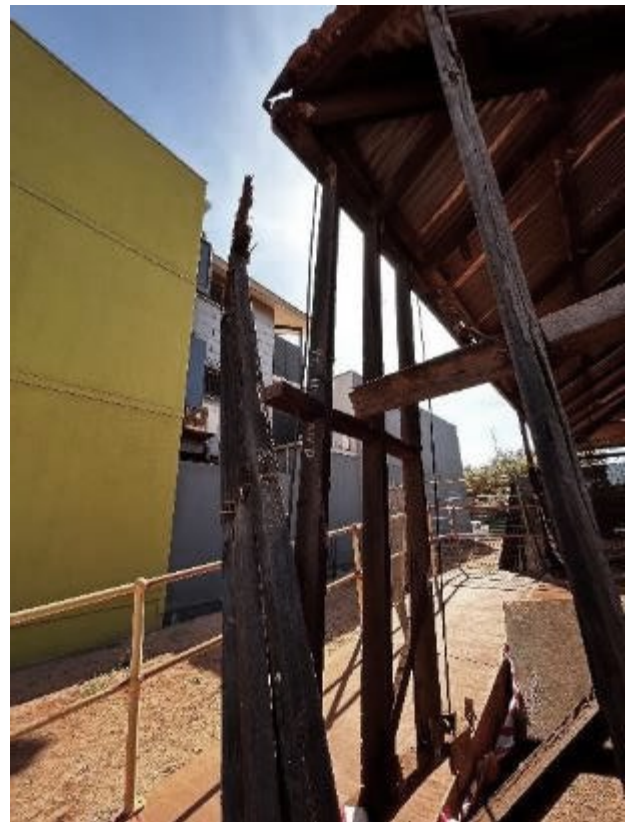
Figure 70: Damaged verandah timbers

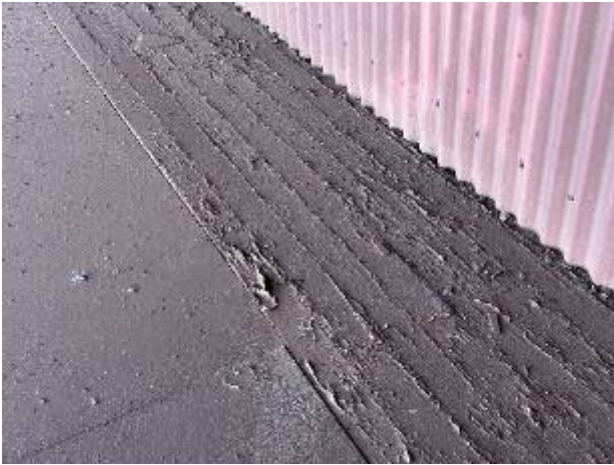
Figure 71: Deteriorating verandah timbers

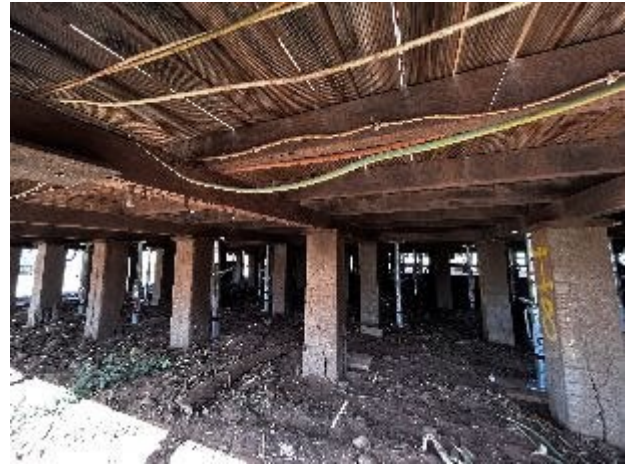
Figure 74: Unsafe wiring under the building

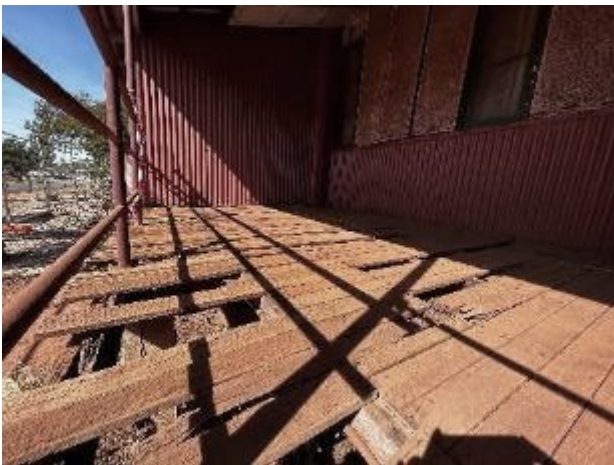
Figure 72: Damaged verandah

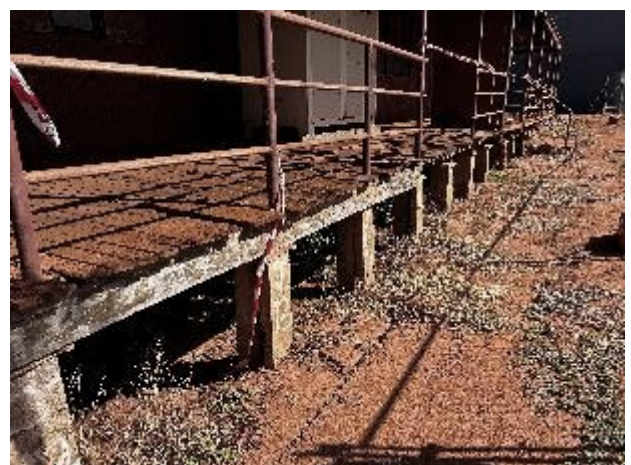
Figure 75: Verandah in poor condition

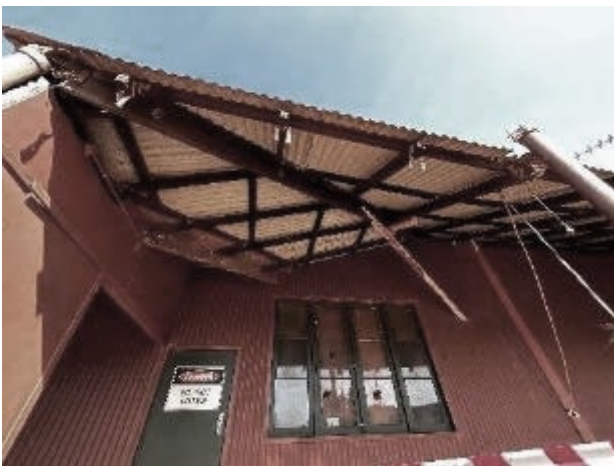
Figure 73: Damaged verandah canopy timbers

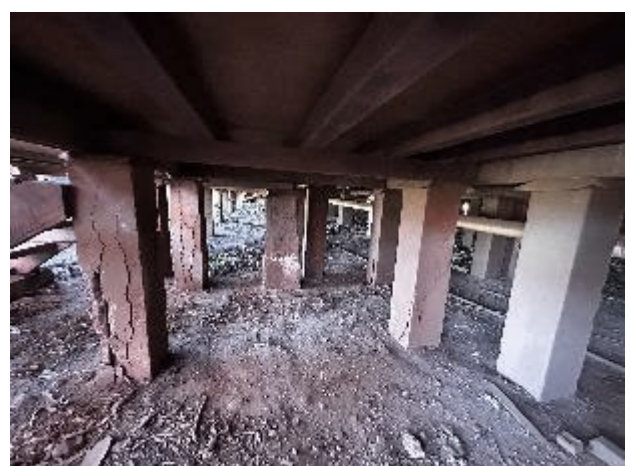
Figure 76: Damaged and replaced concrete stumps

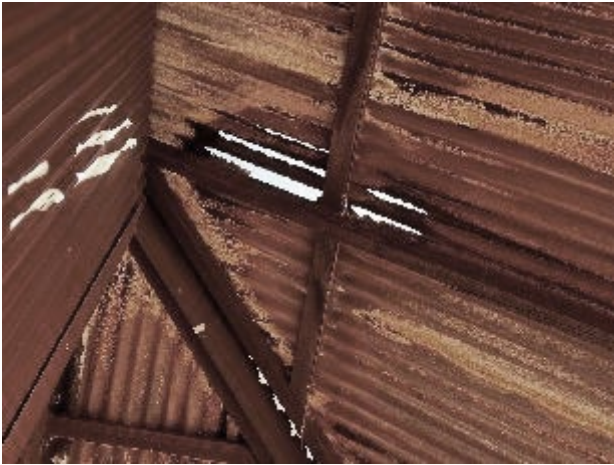
Figure 77: Damaged roof cladding

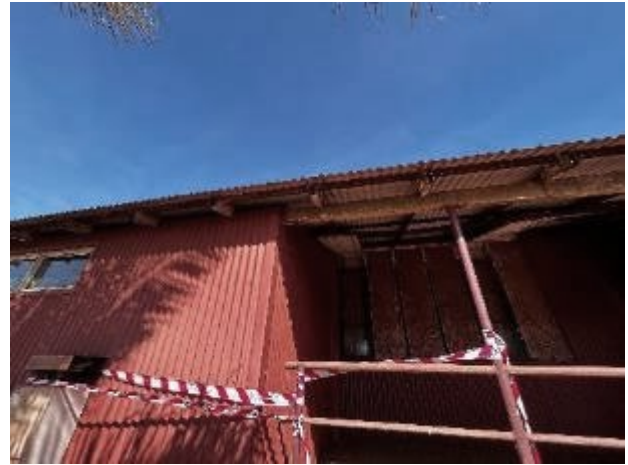
Figure 79: Damaged verandah

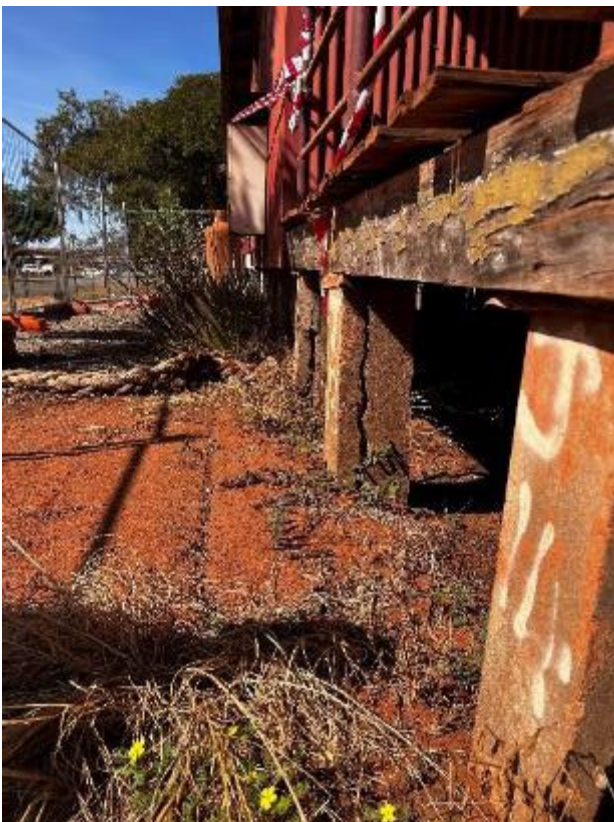
Figure 78: Damaged stumps and verandah facing plate

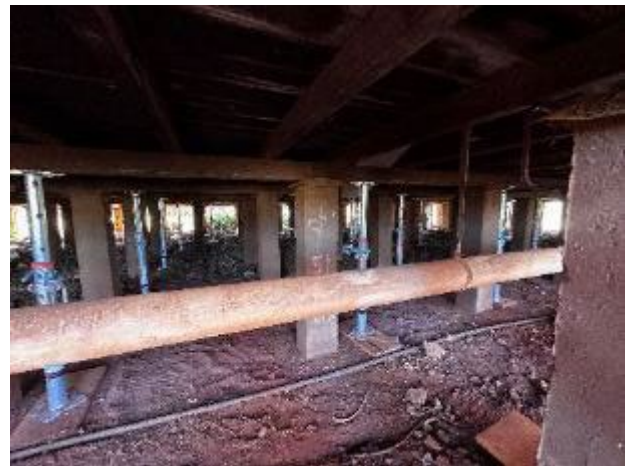
Figure 80: Acrow props underneath building

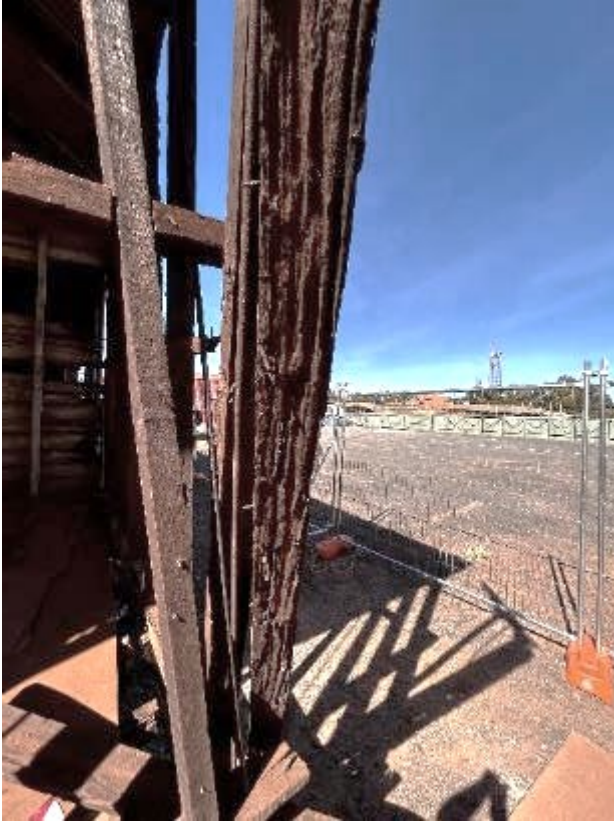
Figure 82: Termite damaged verandah timbers

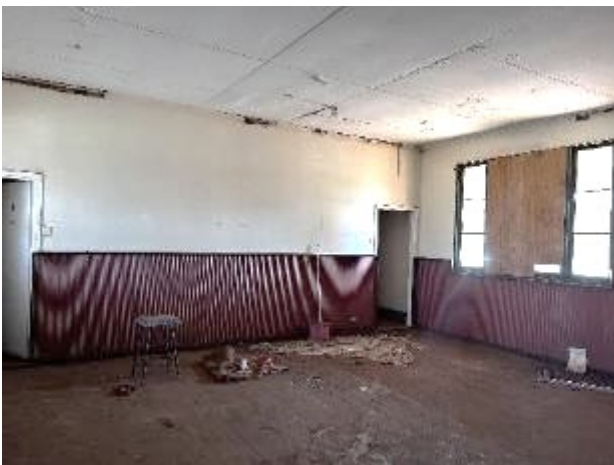
Figure 83: Damaged ceiling in Main Hall 1

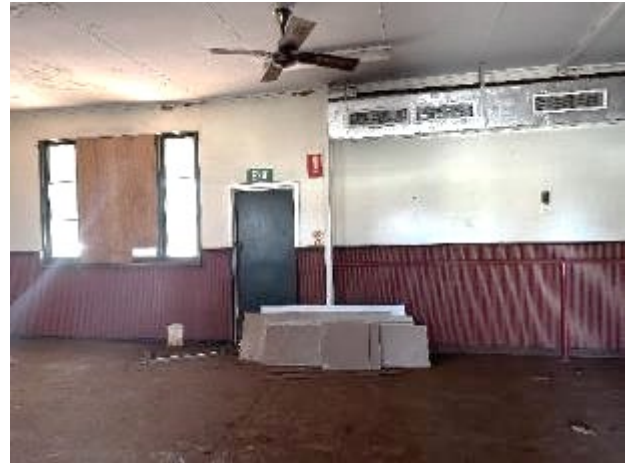
Figure 84: Boarded up windows and loss of wall cladding

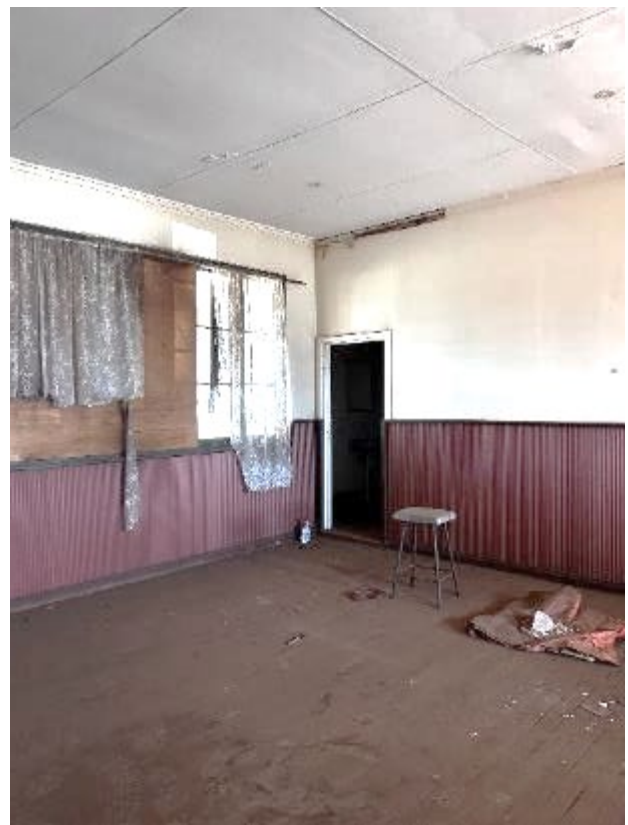
Figure 85: Boarded up window and damaged ceiling

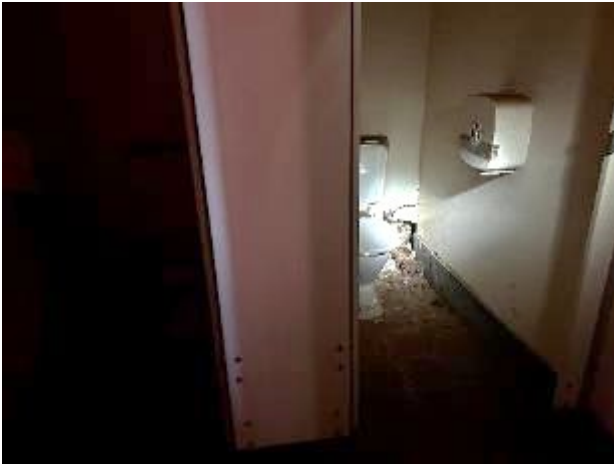
Figure 86: Damaged wall in toilets

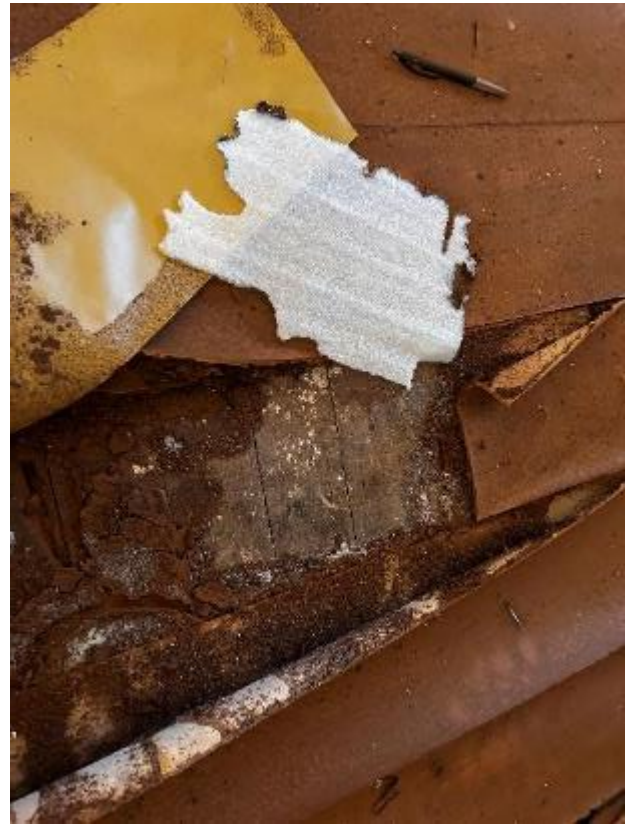
Figure 89: Damaged timber floor in Main Hall 2

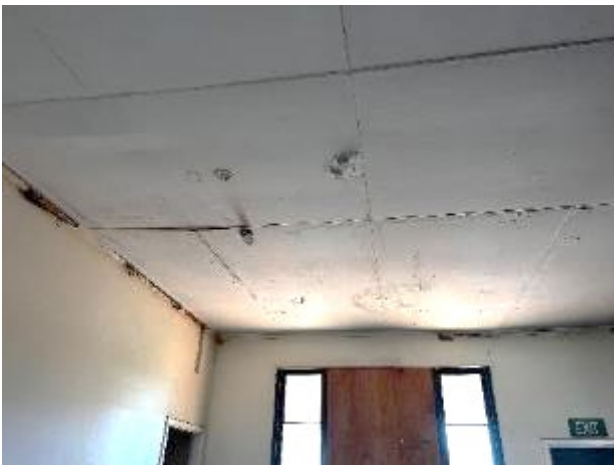
Figure 87: Damaged ceiling in Main Hall 1

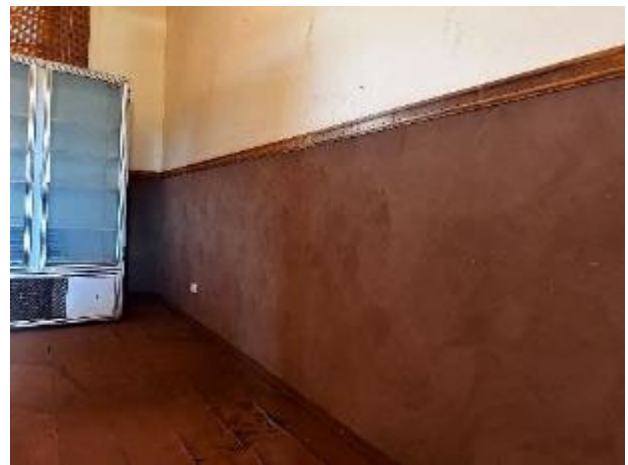
Figure 90: Non-original wall finish in Main Hall 2 (original school room)

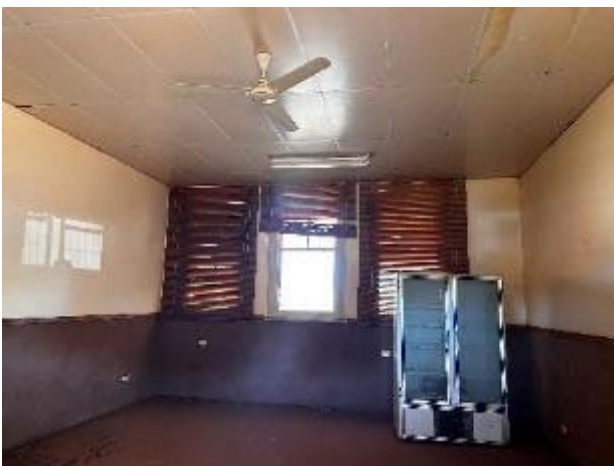
Figure 88: Damaged ceiling in Main Hall 2

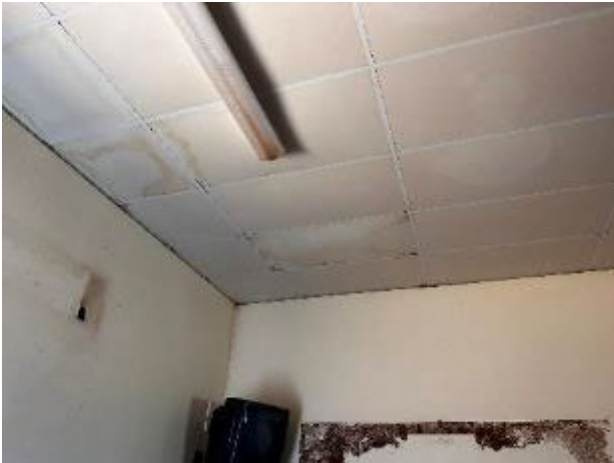
Figure 91: Damaged suspended ceiling in Main Hall 2
