STRUCTURAL CONDITION ASSESSMENT 2023

10 MCKAY STREET, PORT HEDLAND, WESTERN AUSTRALIA

REV	DATE	DESCRIPTION	ORIG	CHK	APPR
0	3-March-23	Issued for AIE Review	MR	NVT	KB
Document Number	AU23-030-05-001_1 - 10 McKay Street Port Hedland.docx	Total No. Pages Including Cover Sheet	29

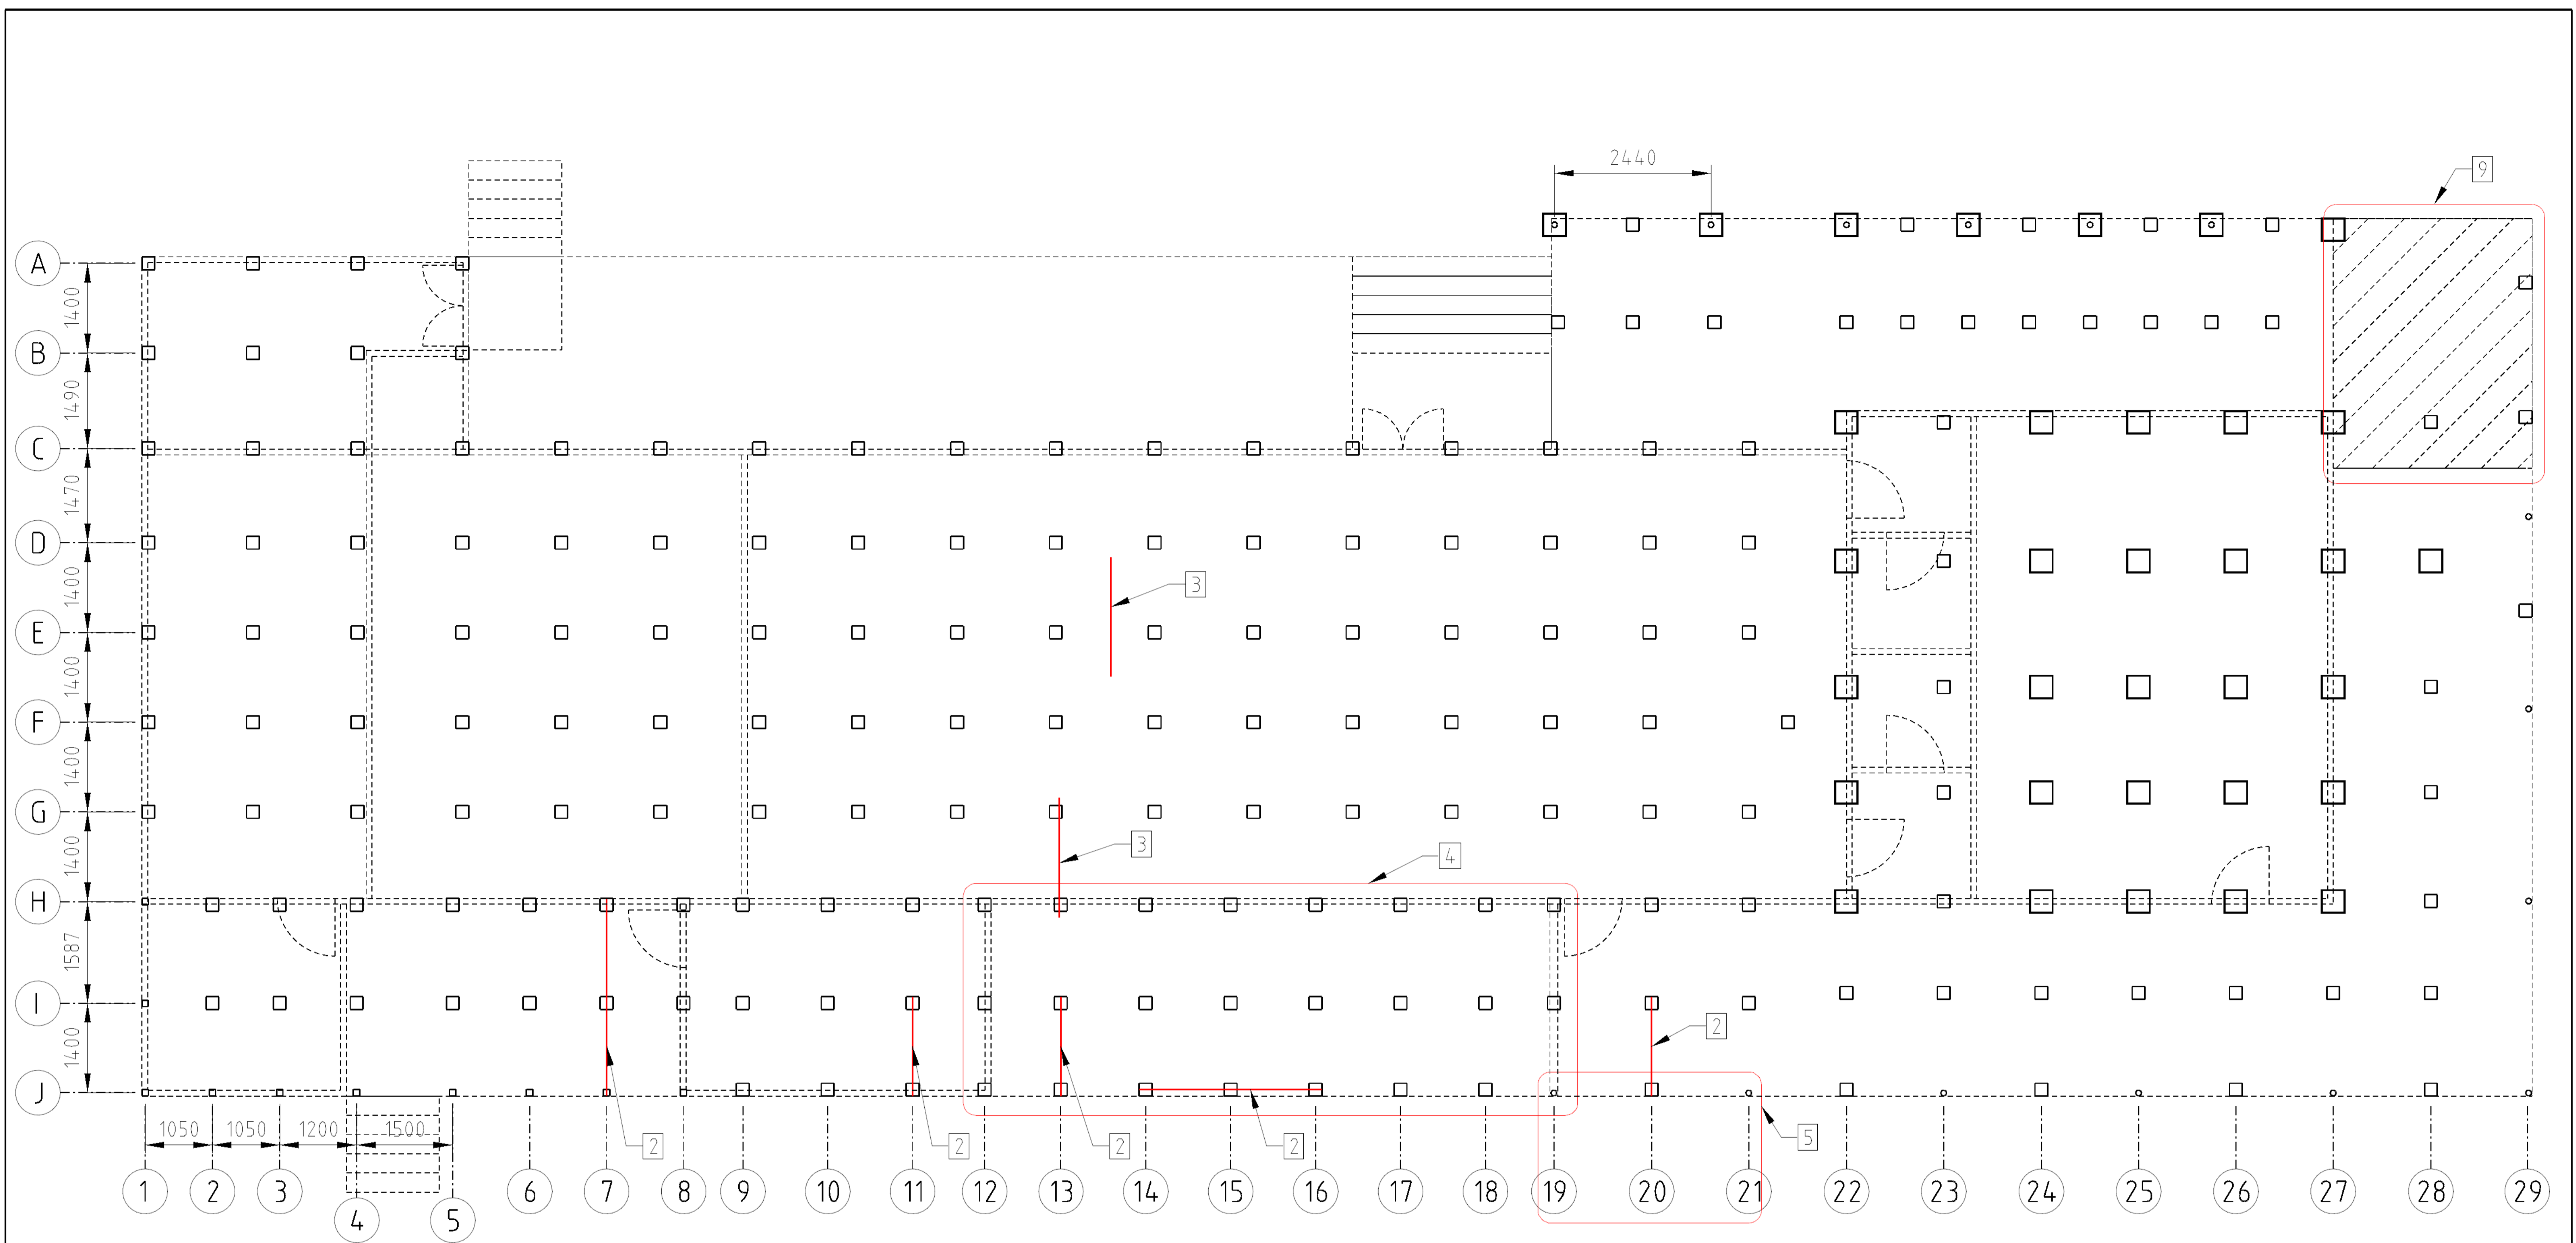
FOUNDATION LAYOUT
SCALE 1:100

Defect ID	Asset Element	Observation Location	Observation Description	Priority Ranking	Photo Ref
1	Concrete footing	Subfloor – Gridline 1 to 9 of drawing AU23-039-06-001	All the stumps on grid 7, 8, 9 and grid H and I (around 50% of the stump of the Southern end of the building) sustain hairline cracks mainly at the foundation areas and the crack extends to around 25% to 50% of the stump length. Isolated cases of concrete spalling on some individual stumps on grid A and B. The cracks and concrete spalling on the stump around the embedded steel can be either caused by impact or corrosion of the reinforcement.	P1	1 (a) to 1 (f)
2	Floor Bearer / Joists	Subfloor - General	Floor bearers and joists have visible termite damage in various areas.	P2	2 (a) to 2 (f)
3	Floor Bearer	Subfloor - General	Some floor bearers have splitting of the timber in various areas.	P2	3 (a), 3 (b)
4	Floor	Floor - Veranda	Between grids H12 and J19 there are various sections of the veranda floor that are damaged due to termites and timber rot with other sections of the veranda floor missing.	P2	4 (a), 4 (b)

12	Concrete footing	Subfloor – Gridline 9 to 29 of drawing AU20-030-001	95% of concrete stumps have moderate to severe cracks in the concrete. Significant concrete spalling is visible on individual stumps at the North East side of the building which extends through the entire length of the stumps. Large sections of concrete breakout at the areas around the embedded steel which can be either caused by impact or corrosion of the reinforcement. Erosion of the concrete cover particularly at Western side on most stumps.	P1	12 (a) to 12 (f)

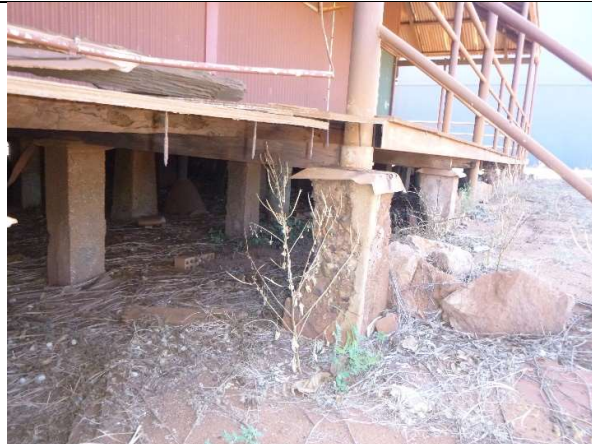
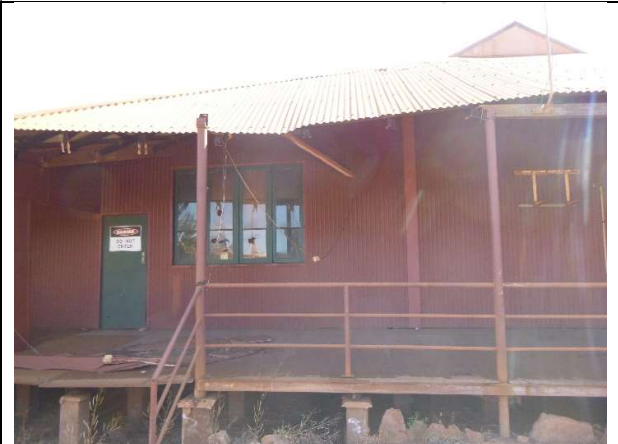
Defect ID	Asset Element	Observation Location	Observation Description	Priority Ranking	Photo Ref
5	Floor	Veranda Stair	There is no access stair to or from the veranda between grids H12 and J19 but there appears to be a stair missing between grids J19 to J21.	P3	5 (a), 5 (b)
6	Roof Rafters	Roof - General	Most rafters and battens within the building roof area (excluding the verandas) are still in good condition when viewed from a distance at inspection points. Not all rafters and battens were inspected due to access limitations. There were some splitting timbers that were recorded during the inspection.	P3	6 (a) to 6 (d)
7	Roof External	Roof – Southern End	Damaged gutter southern end.	P3	7 (a), 7 (b)
8	Roof General	Front of Building Middle Veranda Section (circa Grid J19-J21)	<p>The veranda edge beam has sustained severe termite damage resulting in local failure and collapse of the beam. The interconnected rafter members have also sustained localised sagging as a result of the failed edge beam.</p> <p>Surrounding edge beams, rafters and other miscellaneous connections are also exhibiting signs of termite damage.</p>	P1	8 (a), 8 (b)

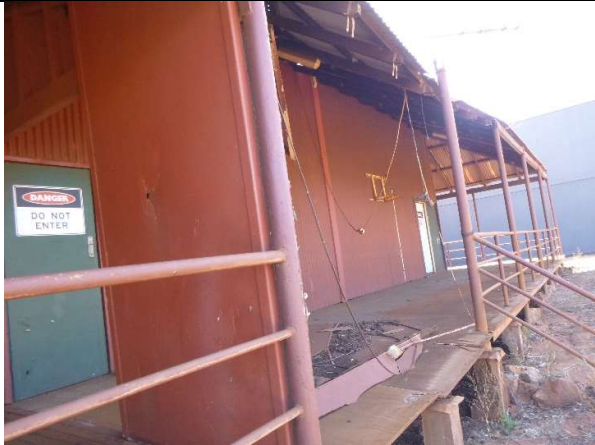
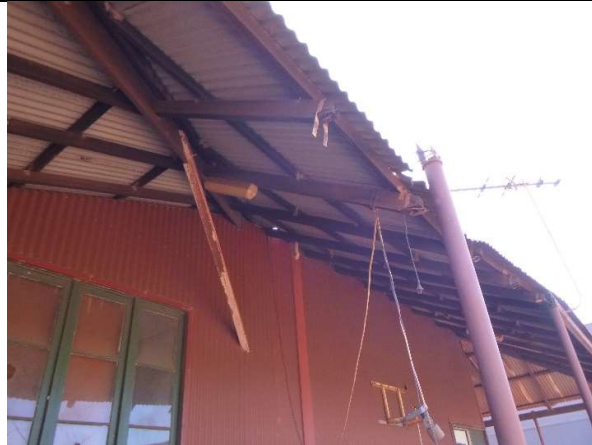
- Three (3) of the defects, Defects 1, 8 and 12, are severe risk and rectifications are recommended to be carried out within the next 3 months. Further development of these defects may cause significant structural damage to the building.

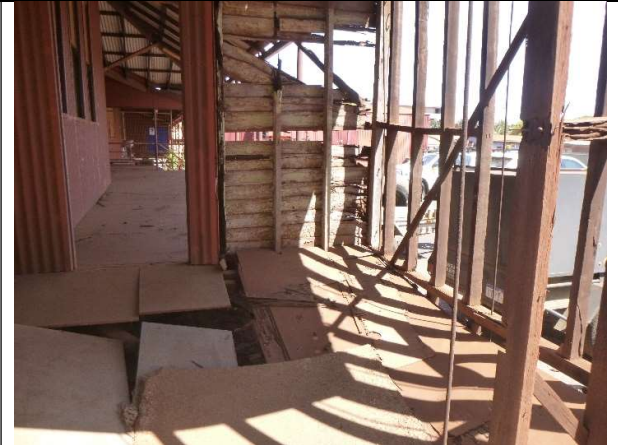
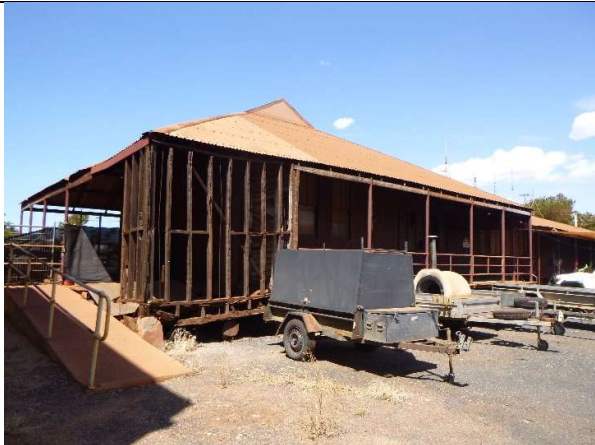
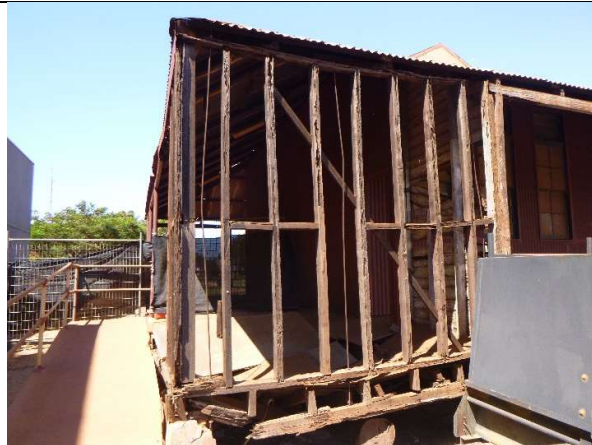
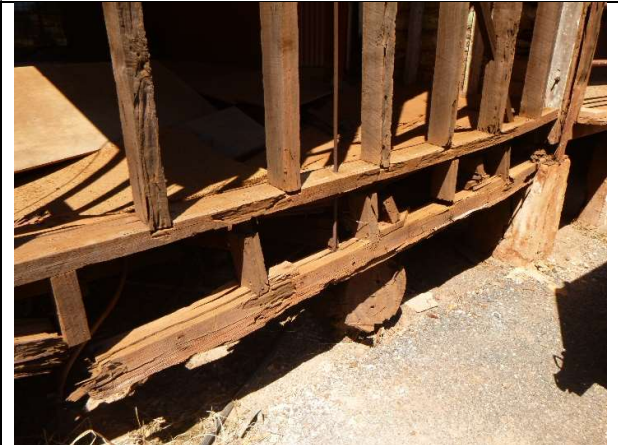
- **Priority 0** - Failure of verandah floor, wall and roof members as a result of extensive termite damage to the North West corner of the building.
 - **Priority 1** - Concrete deterioration to 95% of building stumps of the building on the Northern end and 50% of the stumps at the Southern end resulting in reduced capacity.

Defect ID	Asset Element	Observation Location	Observation Description	Priority Ranking	Photo Ref
9	Floor General	North West corner of Veranda	Collapsing floor area in north west of the veranda. There is extensive termite damage throughout the floor, walls and parts of the roof in this area of the building. This collapsing part of the building is now pulling on the remainder of the building potentially causing further damage.	P0	9 (a) to 9 (d)
10	Internal walls	Walls - General	Due to damaged wall sheeting, termite damage was visible in the toilets and kitchen. The full extent of termite damage is unknown which will require removal of the wall sheeting for further inspection.	P2	10 (a) to 10 (c)
11	External Walls	Walls - General	As noted above in defect 9 there is extensive termite damage throughout the floor, walls, and parts of the roof in this area of the building. Based on the termite damage visible in this part of the building as well as that noted in defects 2, 9 and 10 it is likely that there is further termite damage throughout the building.	P2	11 (a), 11 (b)

- One (1) of the defects, Defect 9, is extremely severe risk as a result of termite damage to floor, roof and wall members. The damage is likely to cause airborne projectiles during a severe weather event, resulting in additional damage to building or surrounding structures. Barricading to prevent access and rectifications are recommended to be carried out immediately.

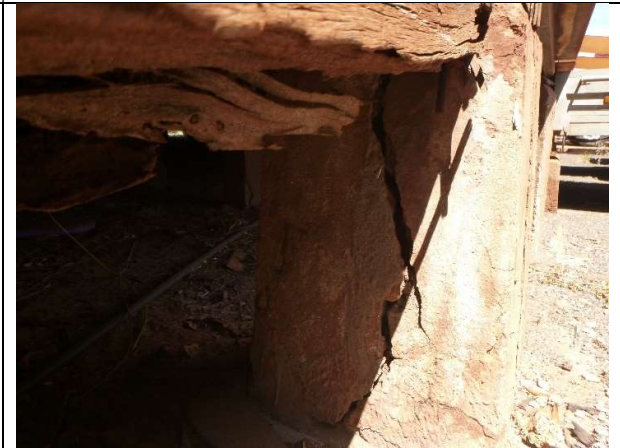
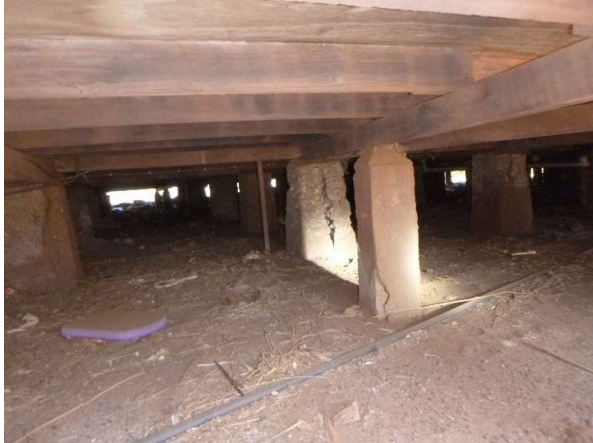
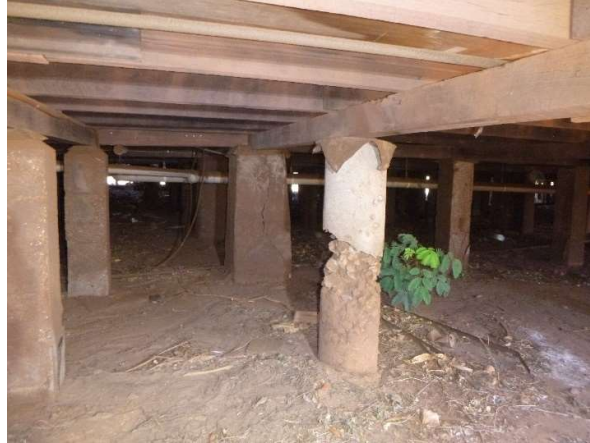
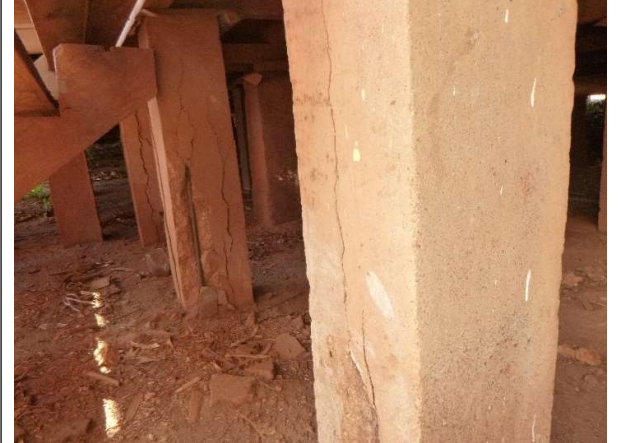
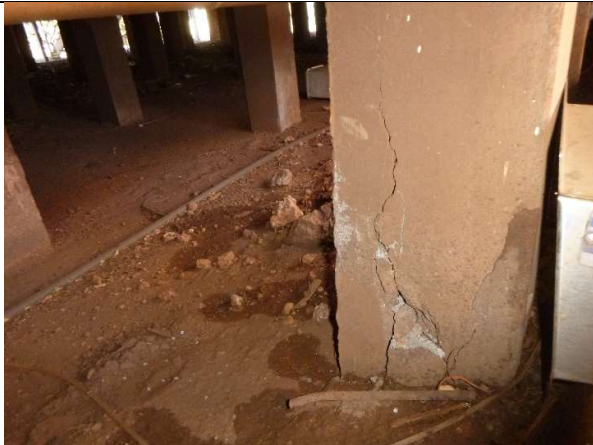
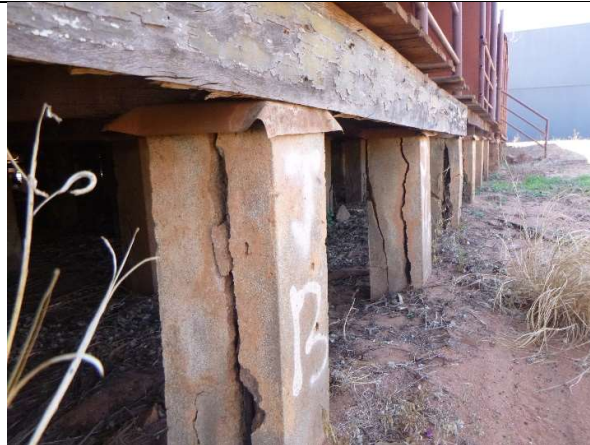
In general, the subfloor has extensive damage observed in the concrete stumps especially at the Northern end and if untreated could lead to failure of building support. This is considerably important during severe weather events when lateral forces on the building are at their greatest. Isolated areas of termite damage were also observed in the floor bearers.
