Report on Geotechnical Investigation at 5531 West Swan Road, West Swan WA

For
Hyquality Group

Reference: GI83221PG_Rev0

Date: 05 February 2021

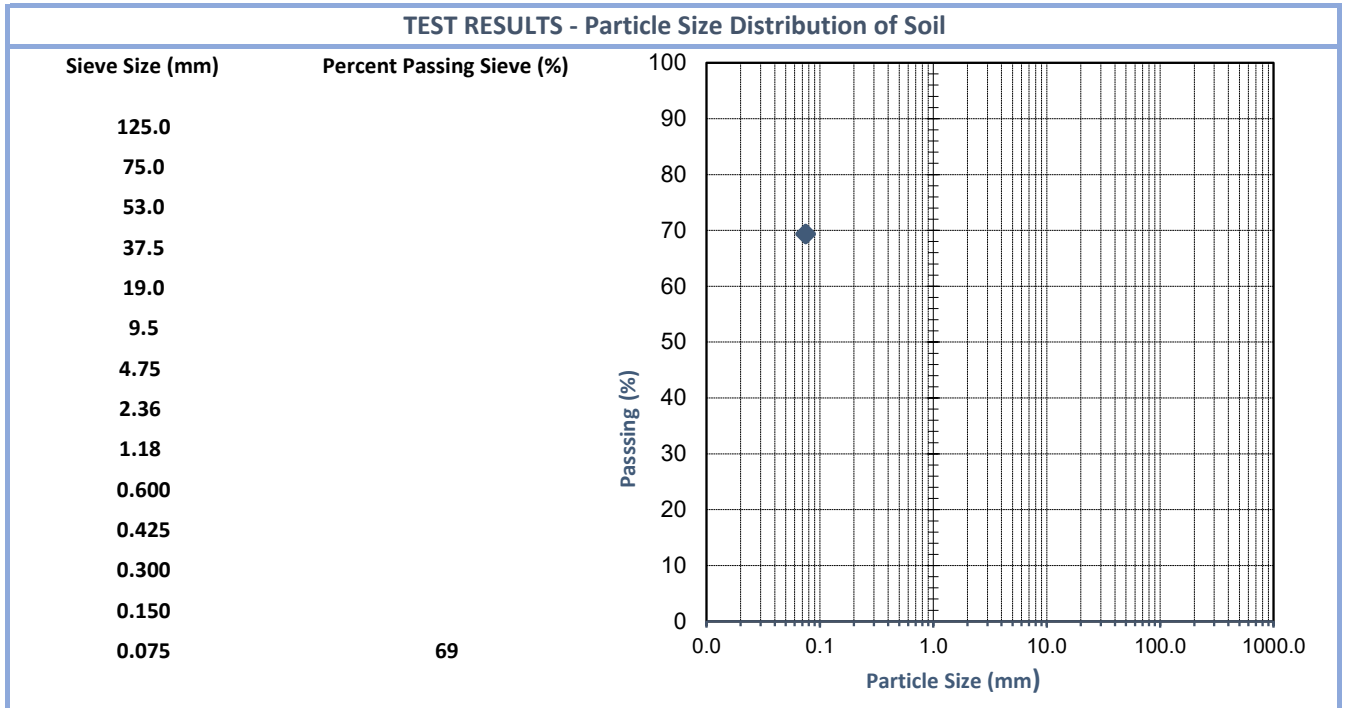
TEST RESULTS - Particle Size Distribution of Soil

Soil Properties	Soil Sample from BH4 (0.3 m to 0.75 m)	Soil Sample from BH4 (0.8 m to 1.5 m)
Fines < 75µm (%)	69	73
Atterberg Limit Test		
Liquid Limit (%)	42	52
Plastic Limit (%)	17	17
Plasticity Index (%)	25	35
Linear Shrinkage (%)	12.0	9.0

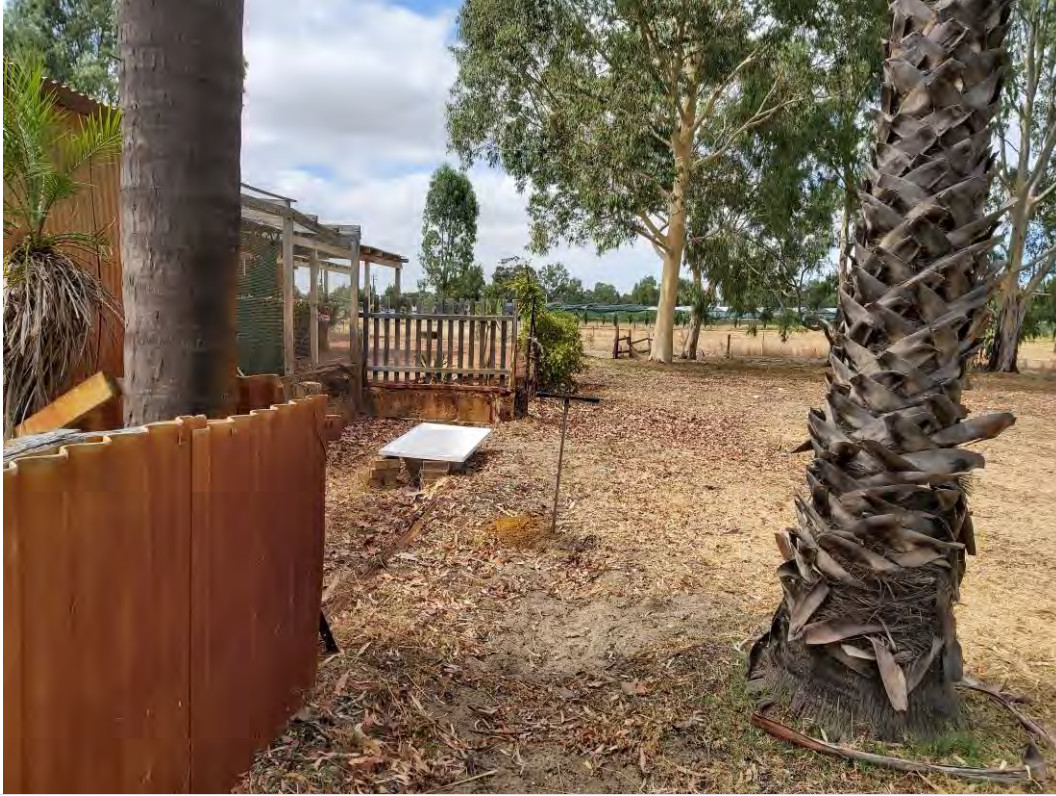
Photo 03: Bore Hole location (BH4), subsurface probing by Hand Auger

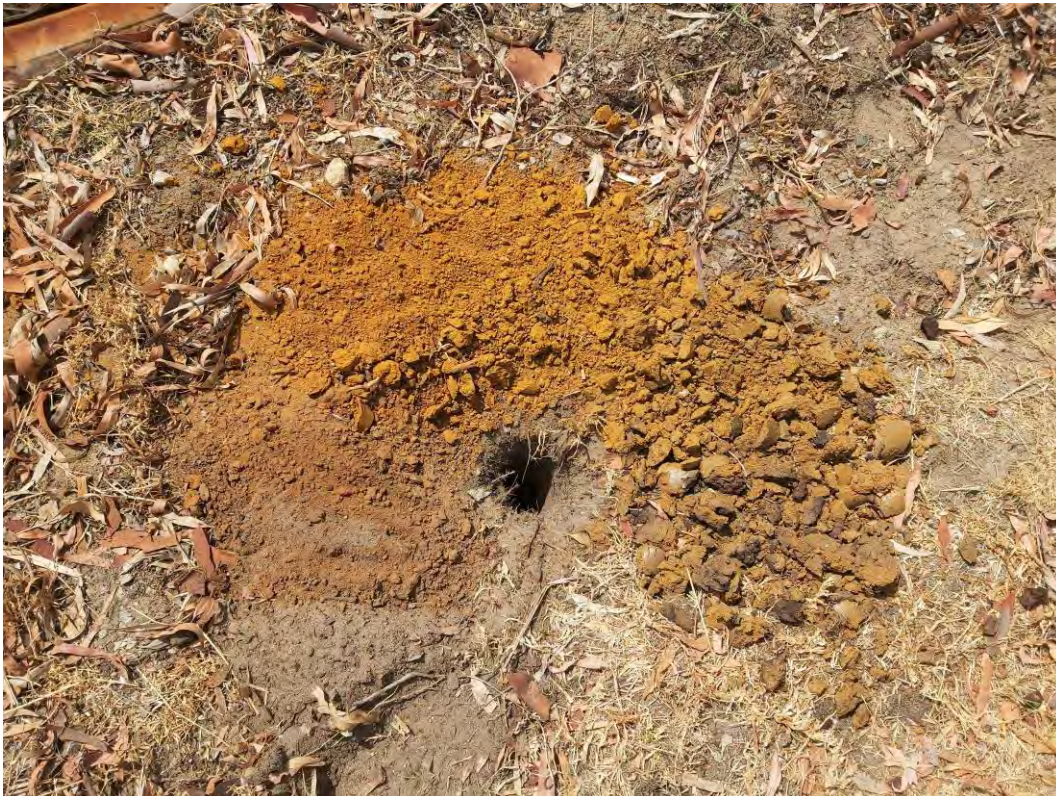
Photo 04: Soil from Bore Hole (BH4)

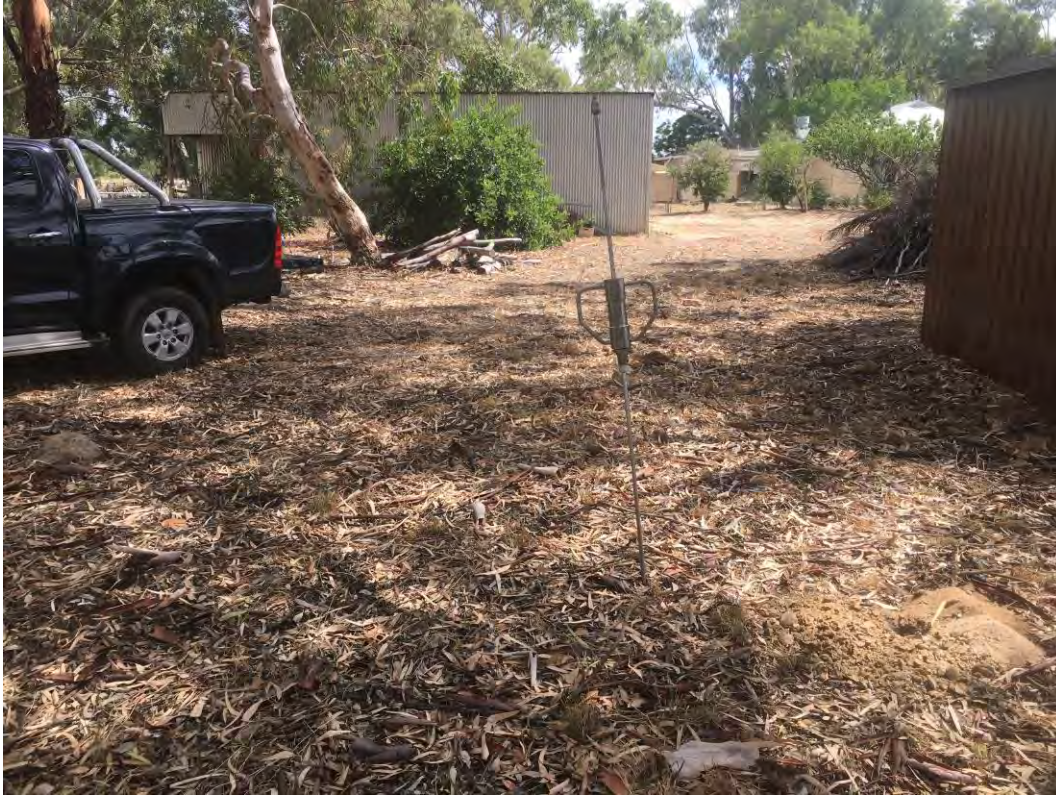
Photo 05: Conducting Dynamic Cone Penetrometer (DCP) Test at location DCP3

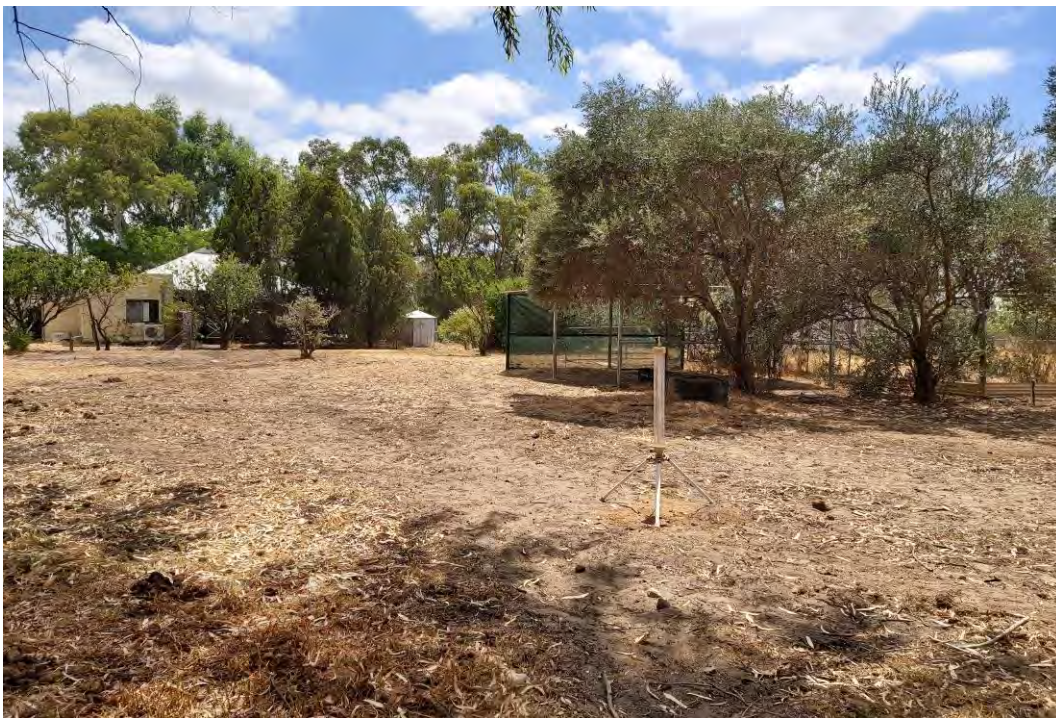
Photo 06: Conducting Field Permeability Test (FPT) at location FPT2

Two (2) Field permeability tests (FPT1 and FPT2) were conducting by using guelph permeameter as per ASTM D 5126 – 90 at two locations. The tests were conducted at a depth of 0.5 m below ground level (bgl). The Guelph Permeameter is a constant head device that operates on the Mariotte siphon principle. It provides a straightforward way of determining the field saturated hydraulic conductivity, matrix flux potential and the soil sorptivity in the field.
