WATER RECYCLING and USE for MIXED USE DEVELOPMENT

SITE and SOIL EVALUATION for WASTE WATER RE-USE

5531 WEST SWAN ROAD, WEST
City of Swan

Aulong Int'l (Australia) Pty Ltd

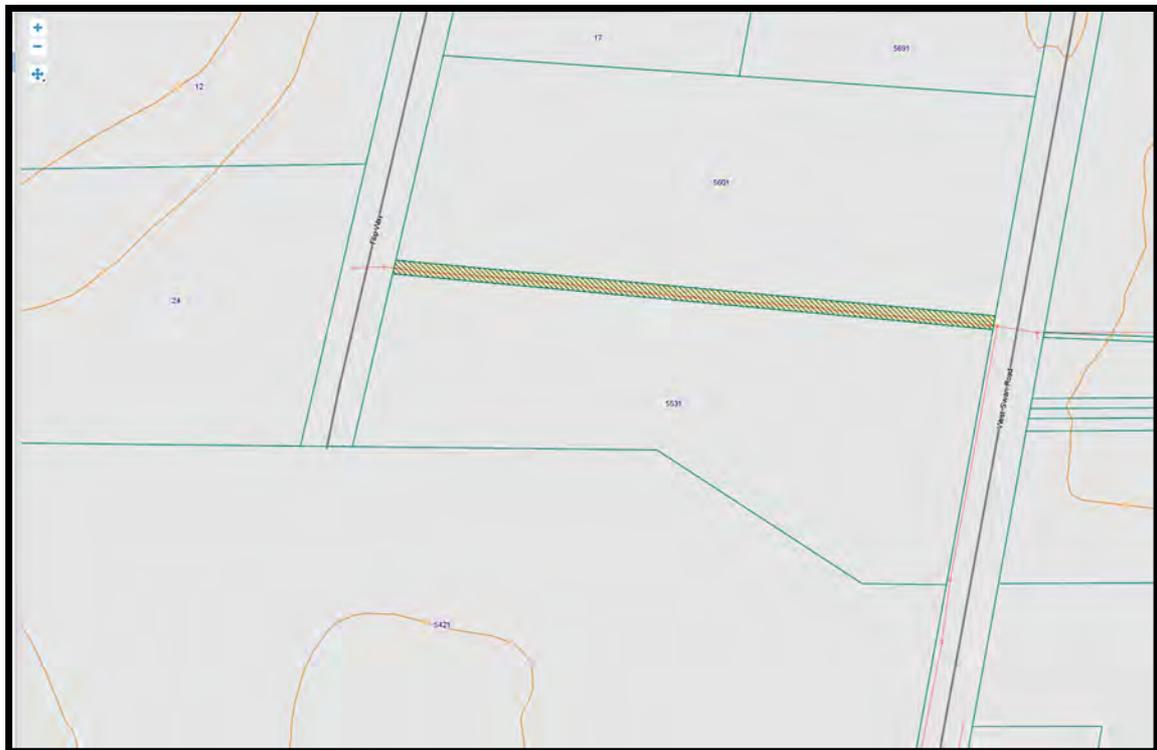
Figure 2: Contour elevations in 1 metre (AHD) City of Swan (IntraMap).

Compare with Figure 7, which uses a local datum, and Figure 7.

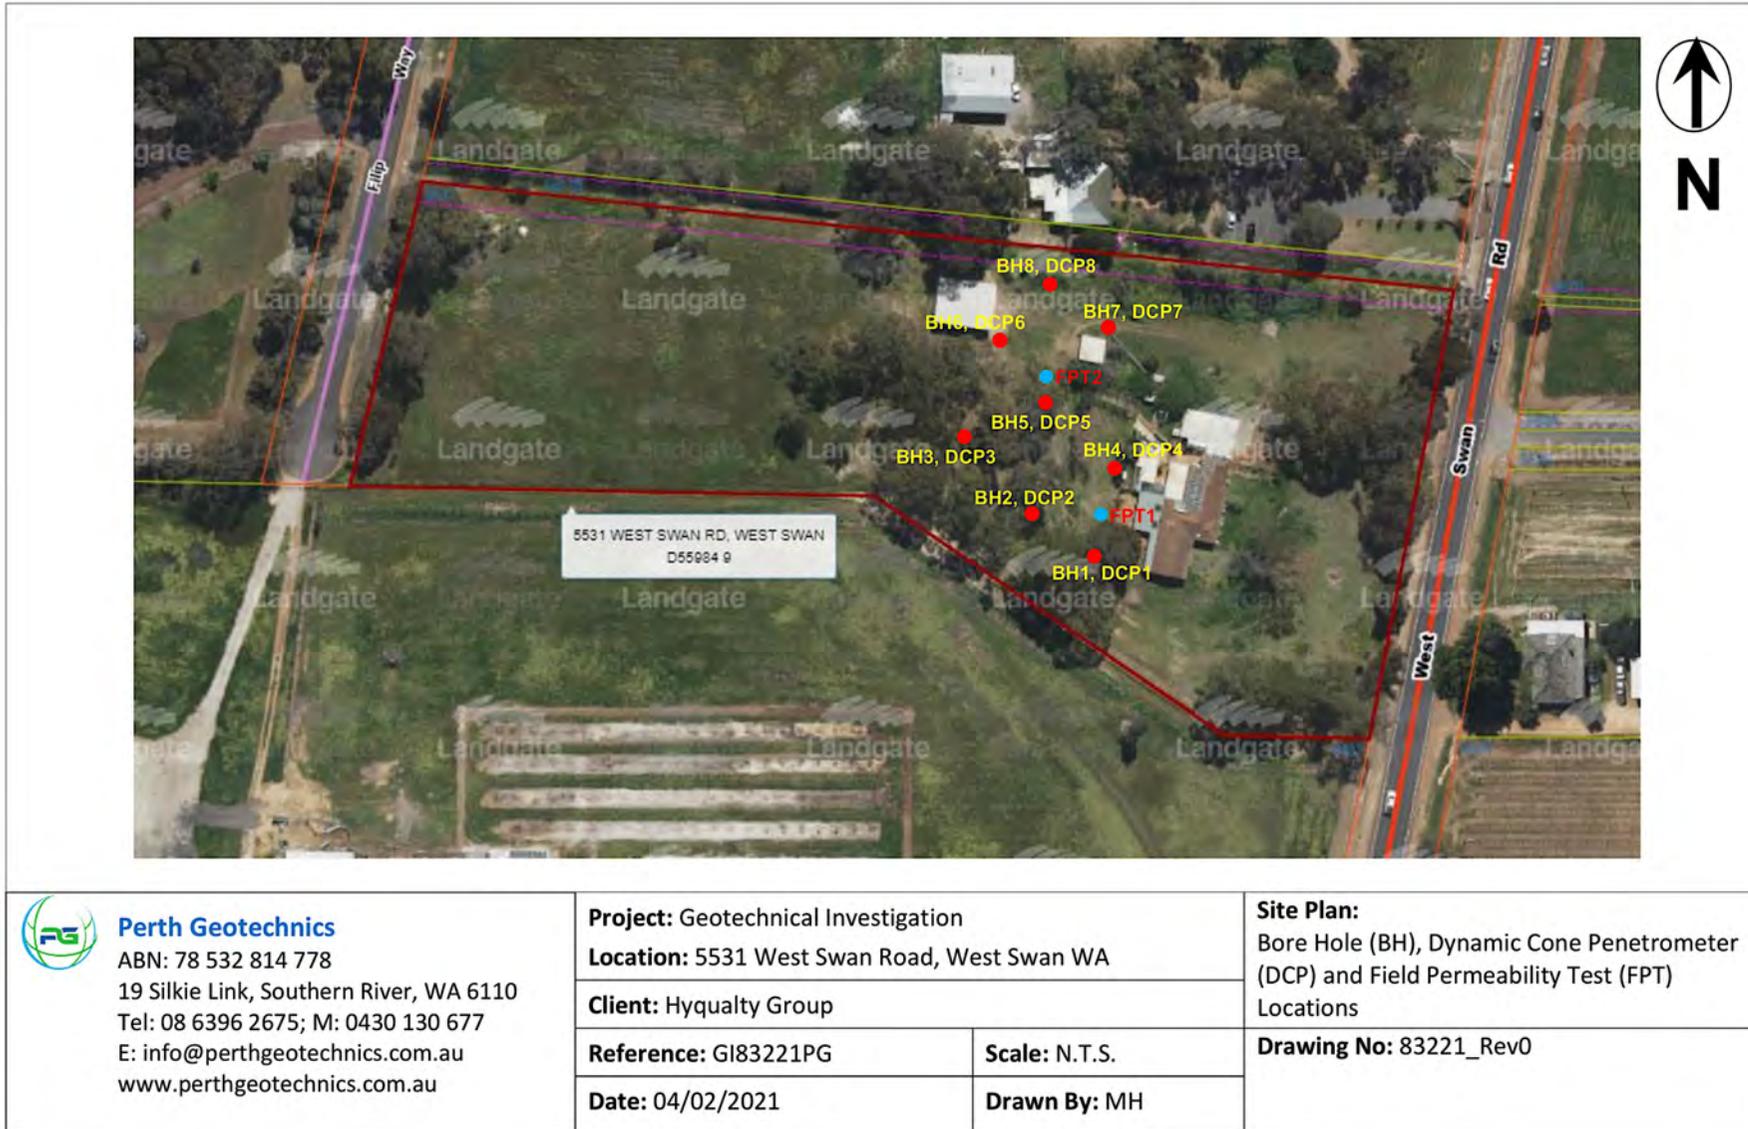
Figure 5: Soil test and permeability test holes - Perth Geotechnics (Fieldwork 14 October 2021)

Perth Geotechnics found that the coefficient of permeability or hydraulic conductivity of the site is varying from 0.58 to 0.81 m/day. See Section 3.3 above and Attachments 2 and 1.

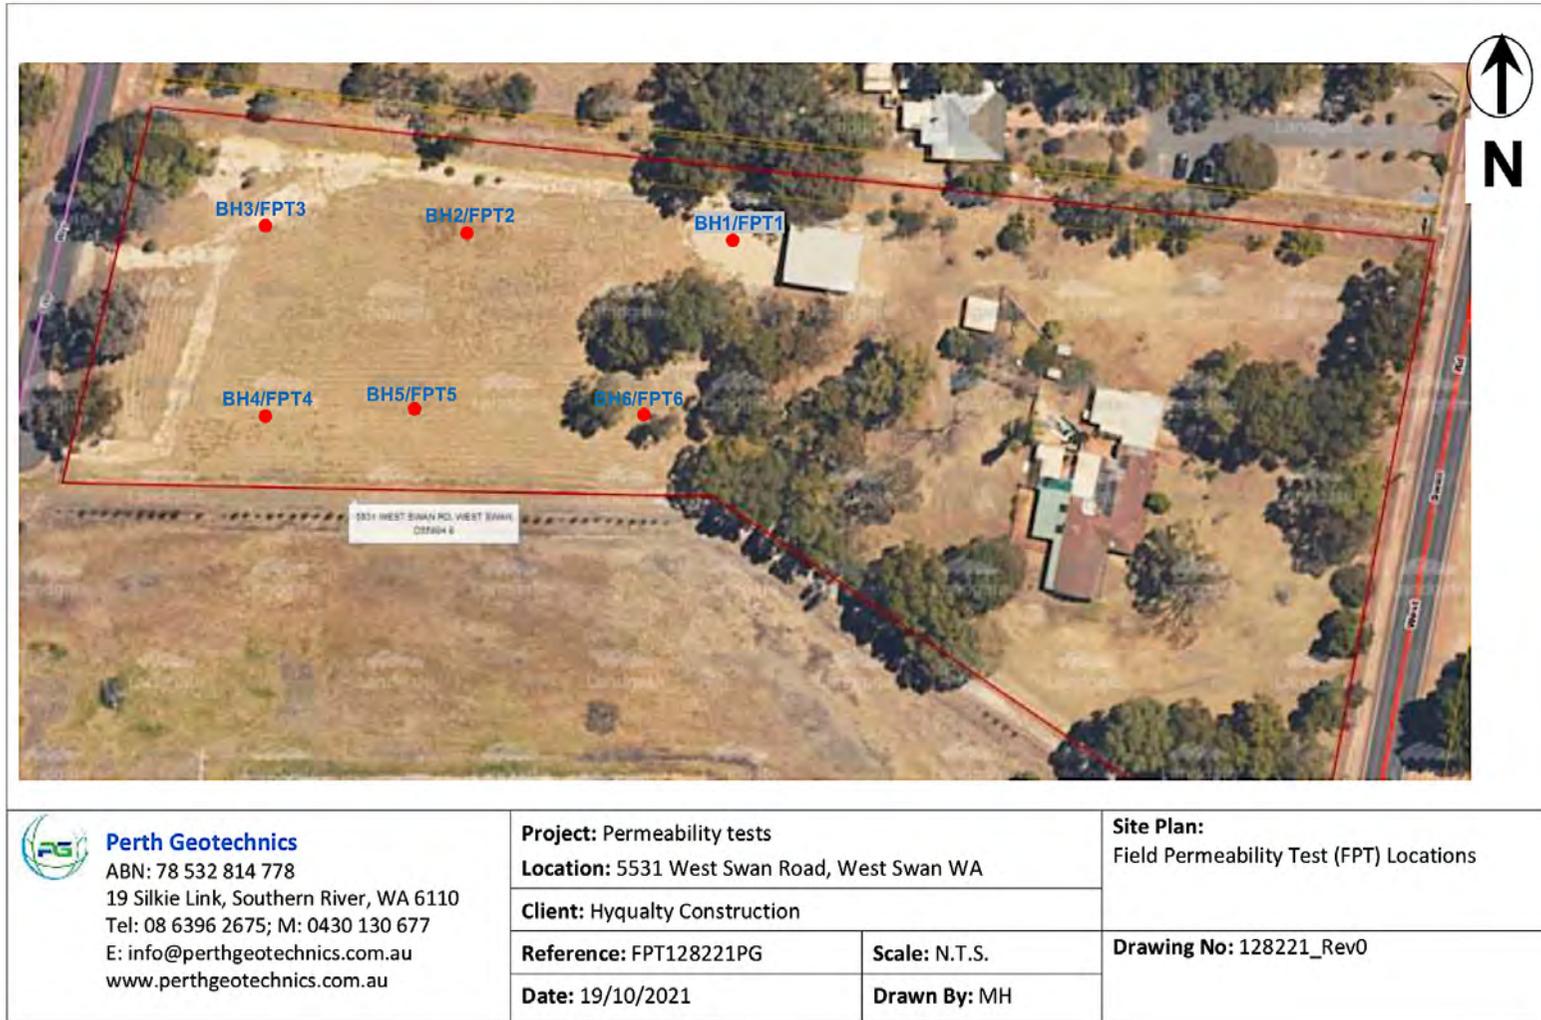
Figure 6: Soil test and permeability test holes - Perth Geotechnics (Fieldwork 14 October 2021)

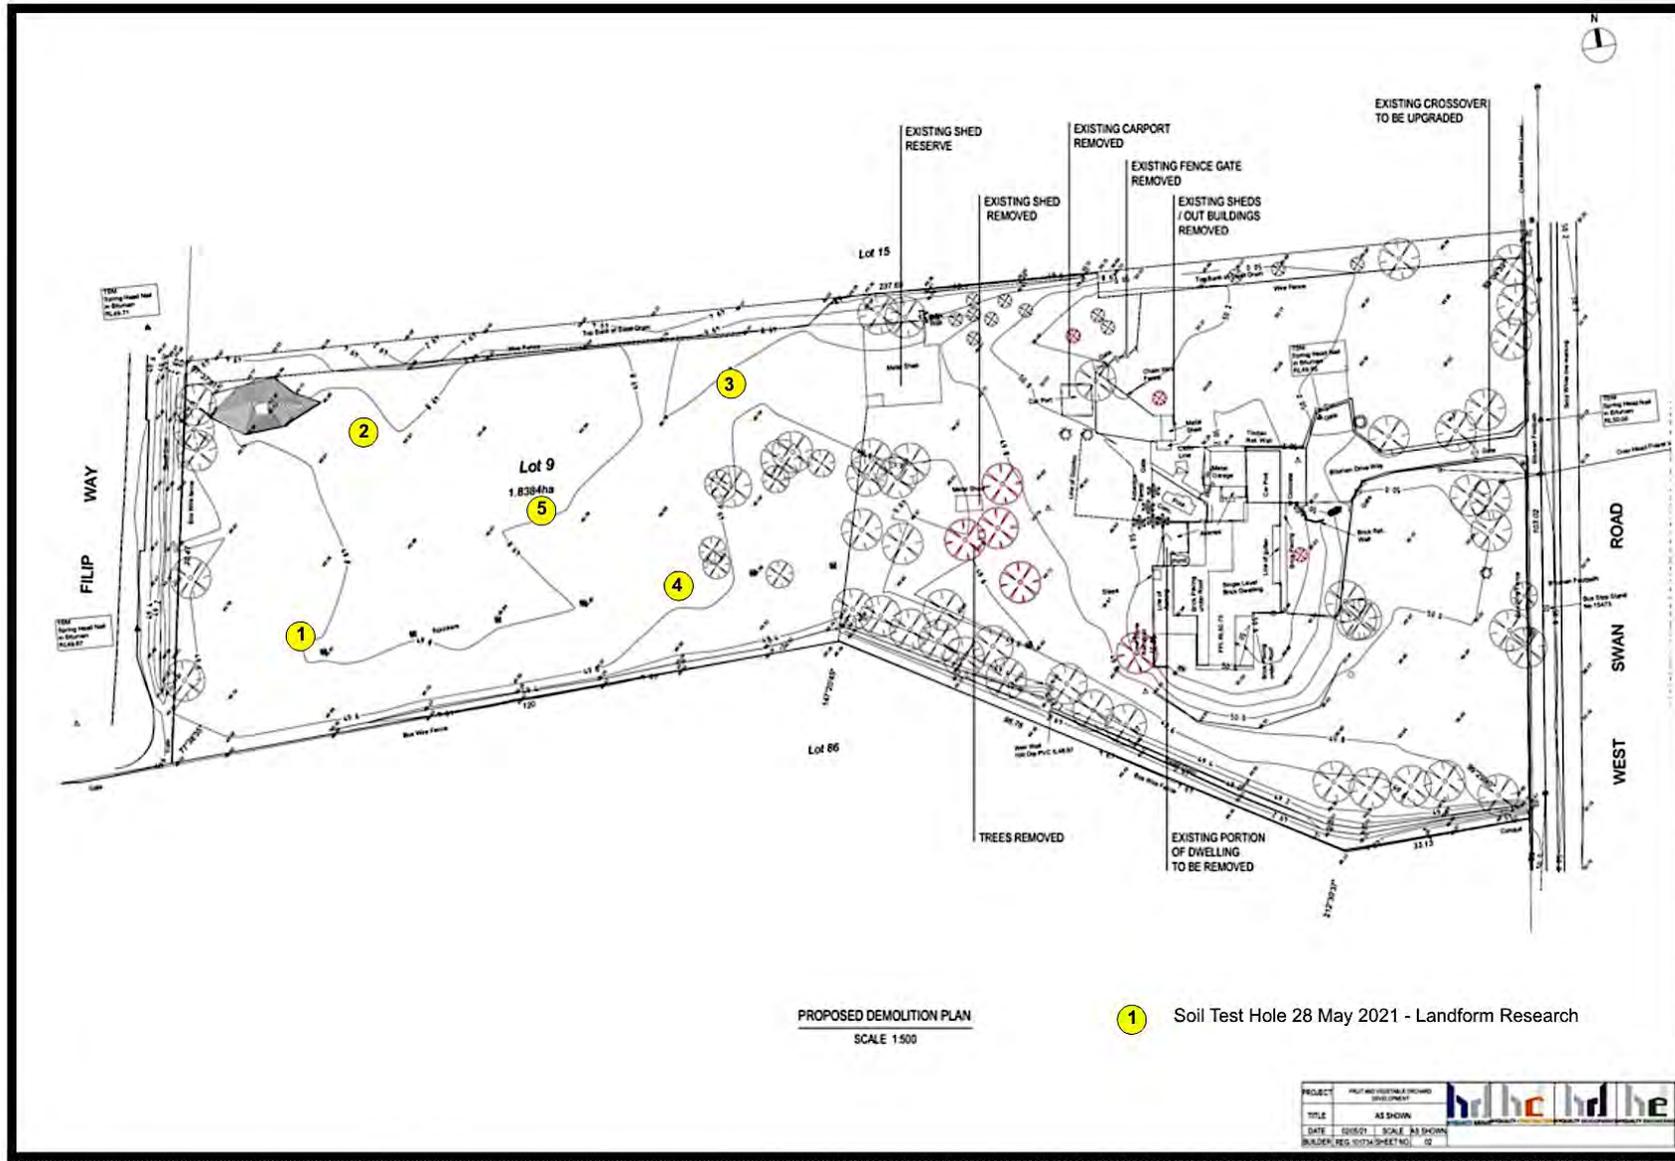
Figure 7: Contour Plan and Soil Test Holes. Note the Local datum. The land is at 17 metres AHD

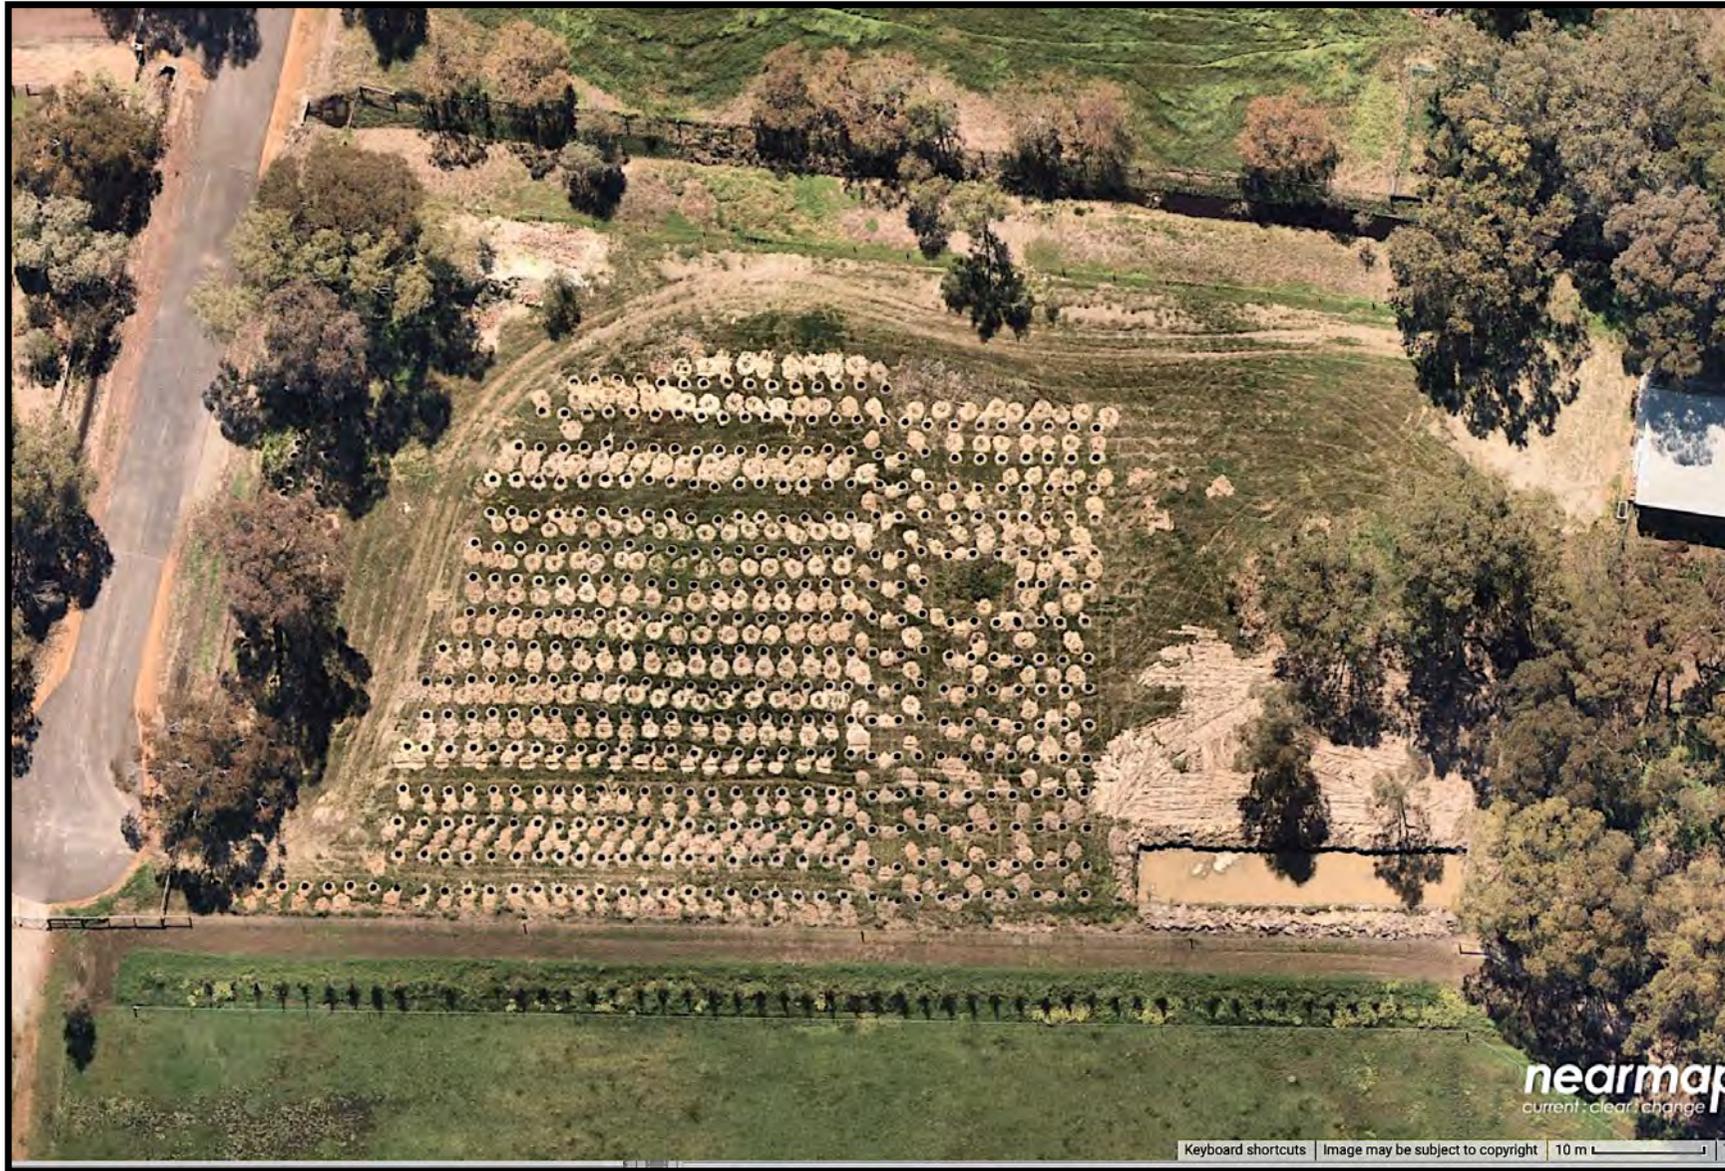
Figure 8: Holes for the planting of Jujube sunk in July - August 2021

When the planting holes were sunk in July – August 2021 a small temporary shallow pit was excavated along the southern portion of Lot 5531 and can be seen in Figure 8. The hole is shallow and the water lying in it at the time of the photo from August 2021 originates from recent rainfall at the time and inflow of surface water from the south, combined with the lower soil permeability of the underlying sandy clay soils which had permeabilities of $6.7 - 9.3 \times 10^{-4}$ or 0.58 to 0.81 metres per day. Table 1.

The proponent has already prepared planting sites across 3,000 m² of the orchard area with space for around 600 trees. The drilled planting holes can be seen in Figure 8.

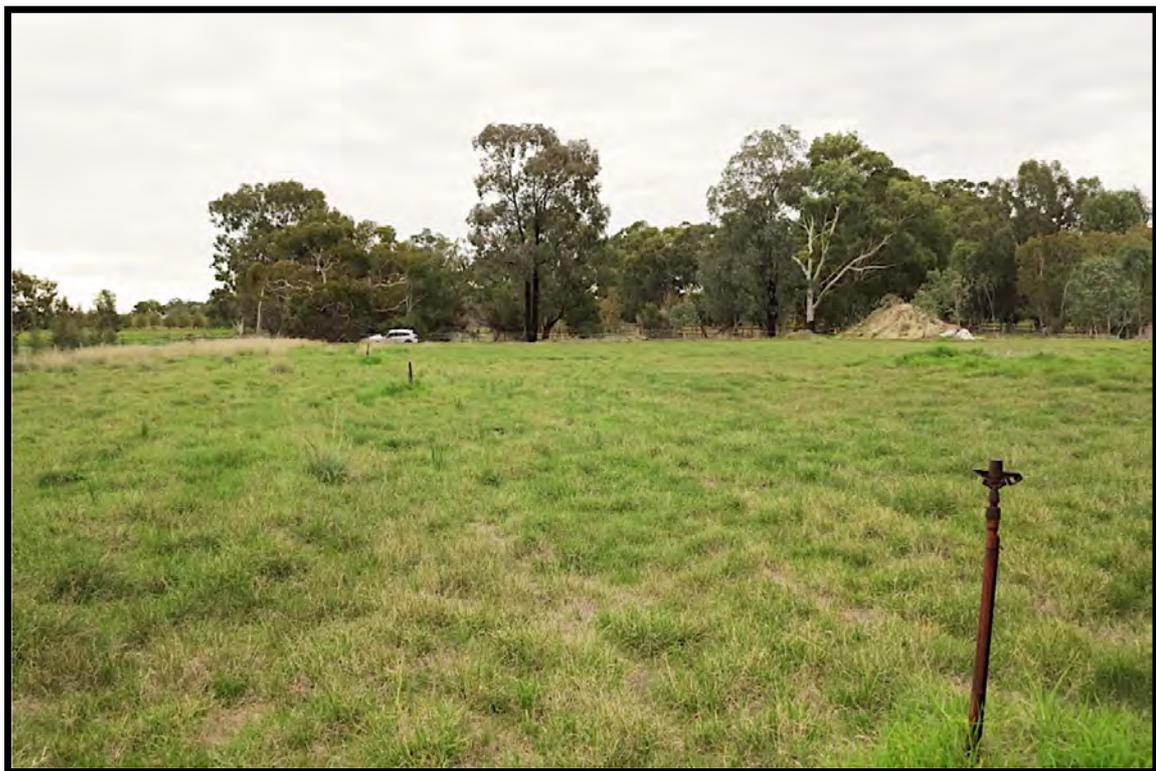
Figure 14: Site photograph of the orchard area/ land application area looking west. Note the existing pasture irrigation.

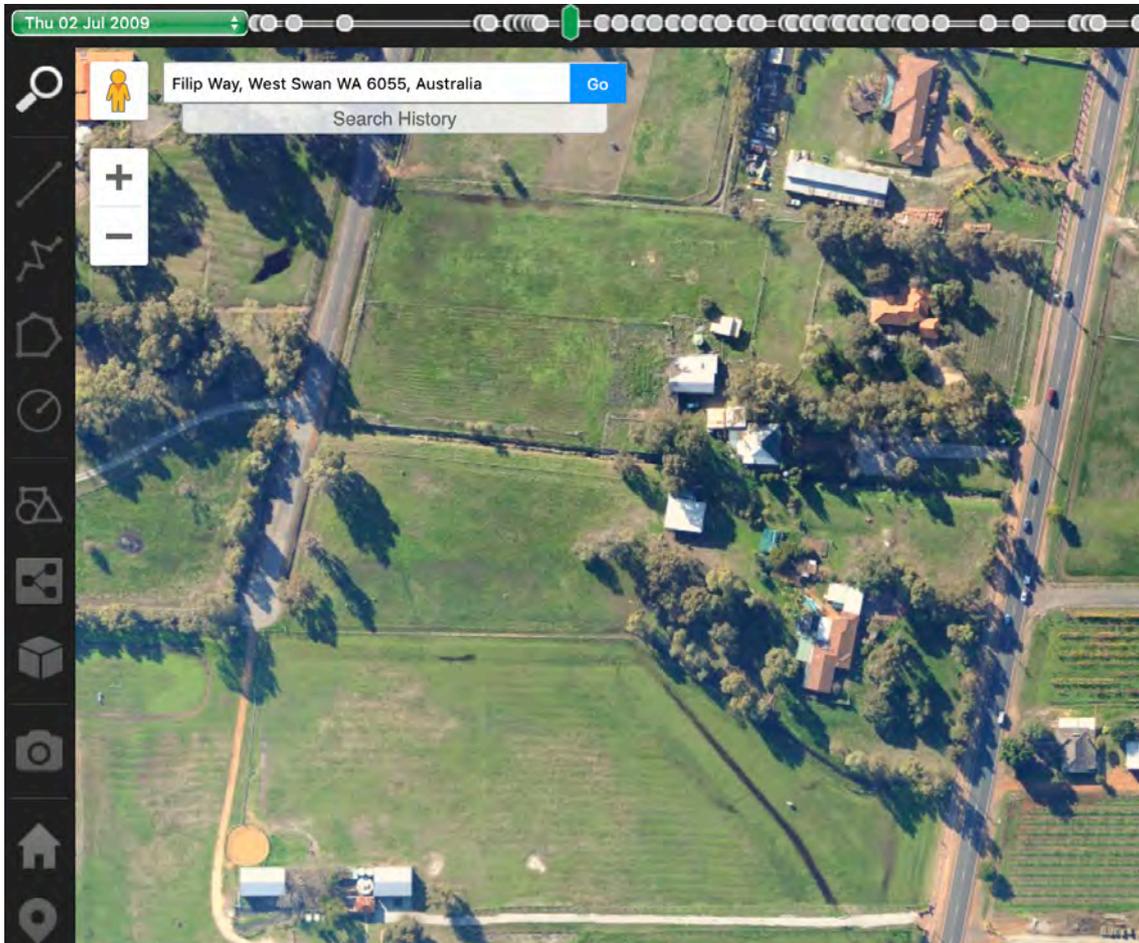
Figure 15: Drains present in winter 2009 prior to fill of the land (Nearthmap)

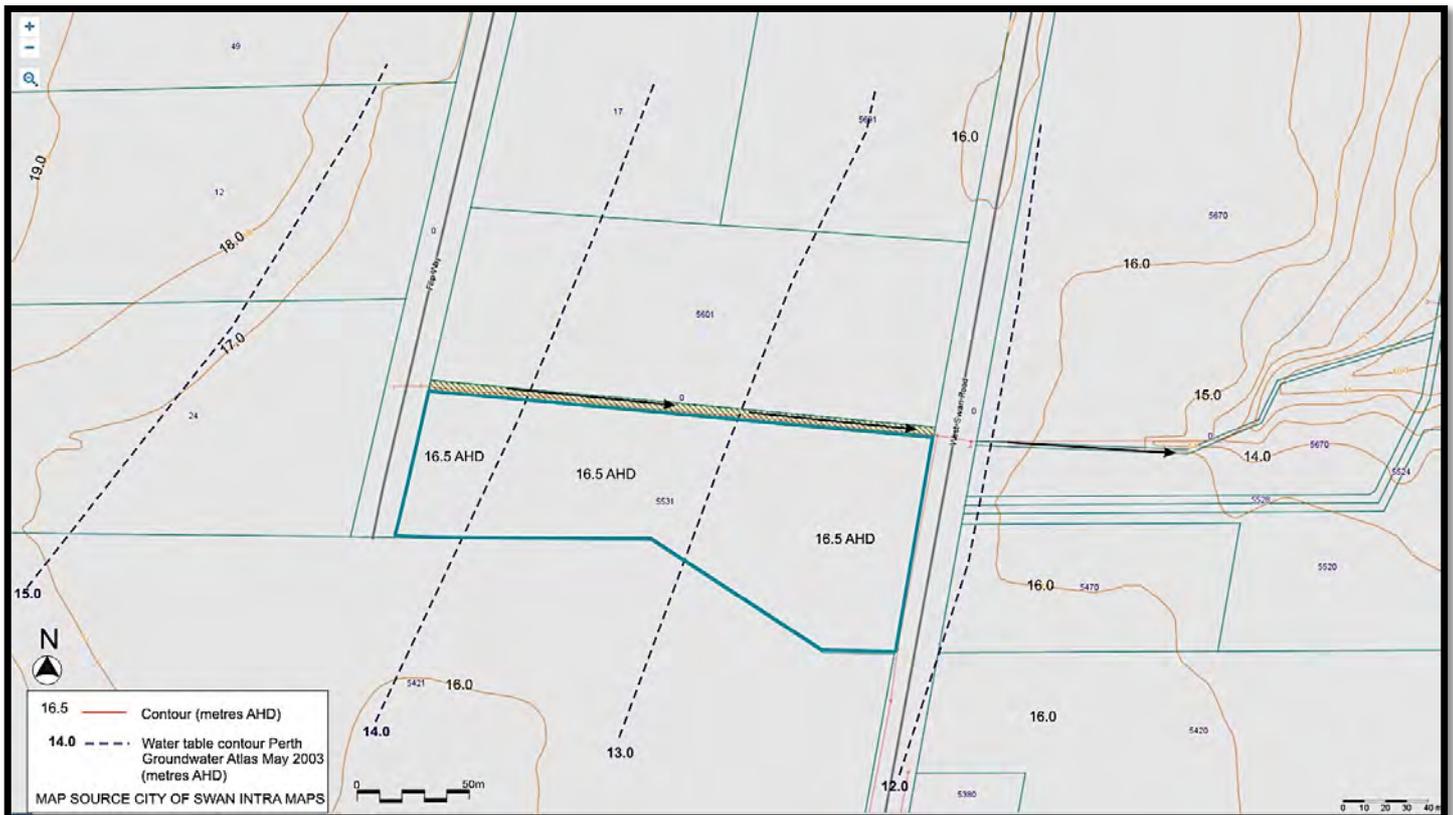
Figure 17: Water table contours May 2003 Perth Groundwater Atlas

The groundwater average depth is listed by Perth Geotechnics as 15.5 metres AHD which is different to the Perth Groundwater Atlas (data May 2003). Figure 17.

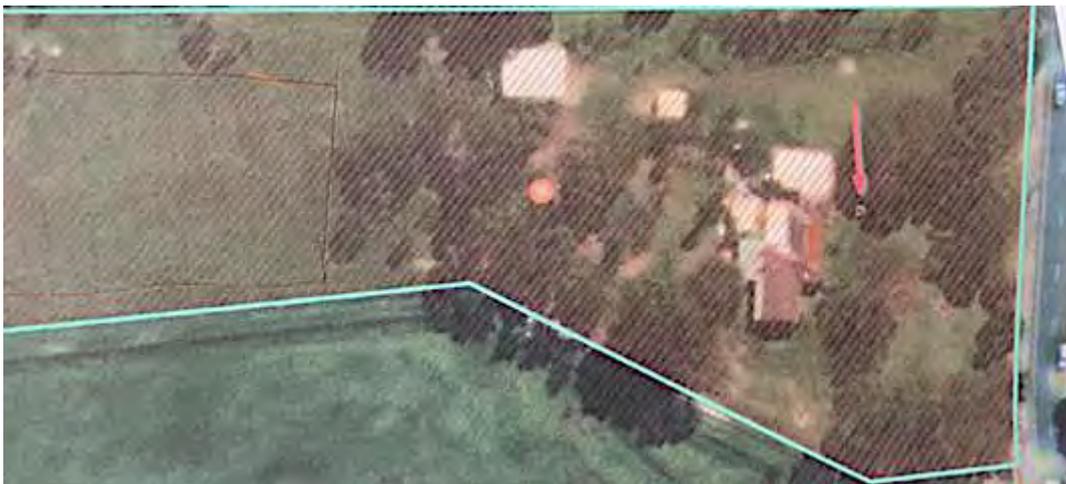
Site reference 61603055 - Swan Coastal Catchment 616 - Bore - Bore

Alternative Site References			
Numbering System	Reference Code	Site Name	Short Name
AWRC	61603055	Swan Coastal Catchment 616 - Bore	Bore
WIN_ID	20026288		Bore
ACWAB	2034-2-NE-0515	SWAN COASTAL CATCHMENT 616 -	Bore

Groundwater is available and there is a licensed bore on site, licensed for 5,000 kL per year. The bore is located just east of the existing dwelling on Lot 5531.

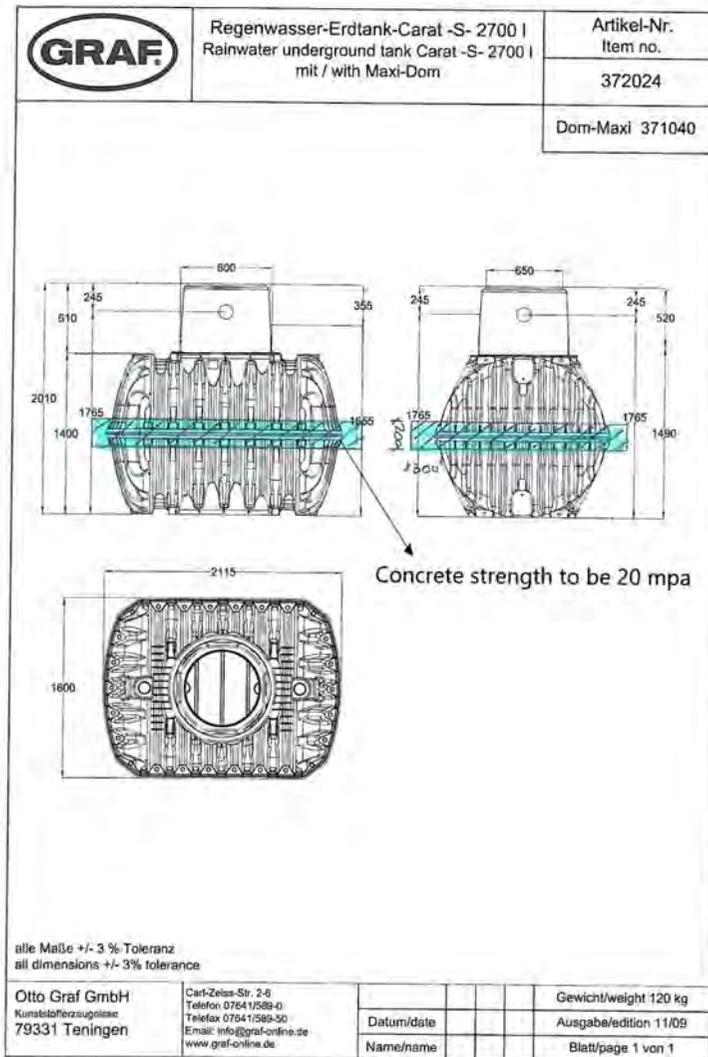
Figure 23: Concrete reinforcing to the tanks to stabilise them in the soil

Considering the soils and depth to the water table, concrete strapped tanks are recommended and are proposed. See Figures 20, 21 and 22.
