# Screen Production Facility, Malaga Site Stormwater and Drainage Management Plan

Prepared for Home Fire Creative Industries  
Issued for DA Review – Rev C

February 2023  
Project Number P21062

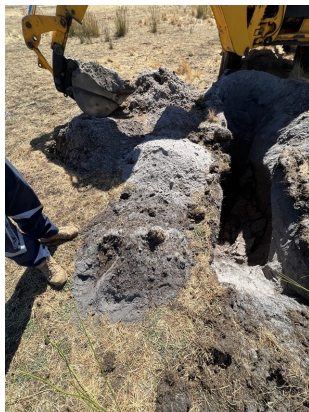
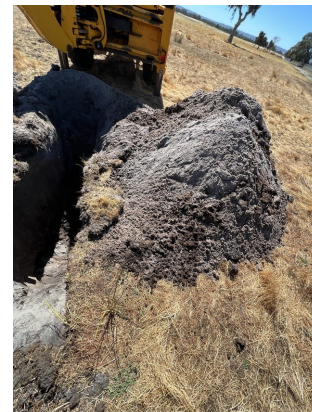
Termination Reason: Refusal: Pit Wall Collapse

Remarks: Backfilled. Groundwater encountered at 1.4 m BGL.

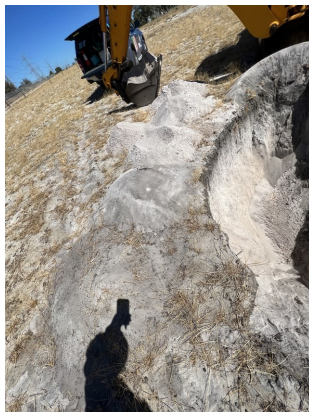
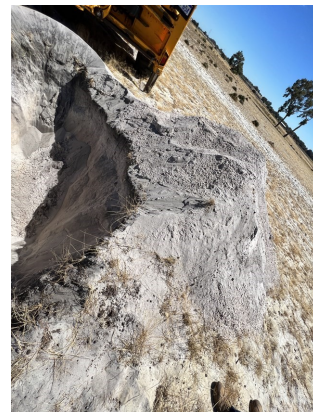
# TEST PIT LOG - TP02

Termination Reason: Refusal: Pit Wall Collapse

Remarks: Backfilled. Groundwater not encountered.

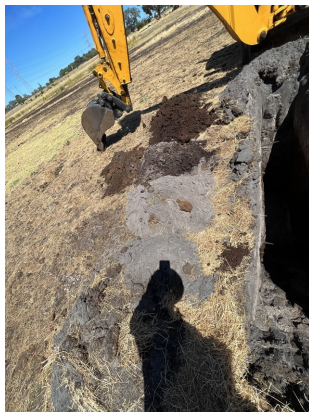
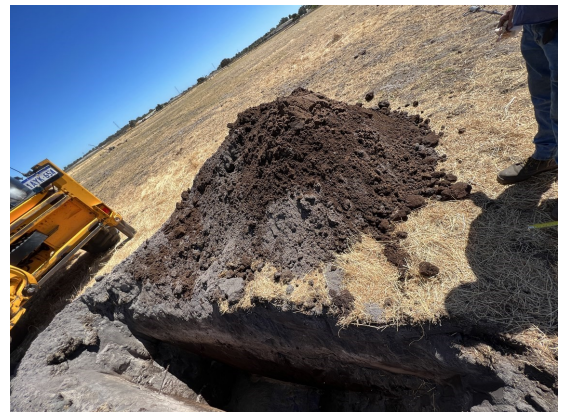
# TEST PIT LOG - TP03

Termination Reason: Refusal: Pit Wall Collapse  
 Remarks: Backfilled. Groundwater encountered at 2.0 m BGL.

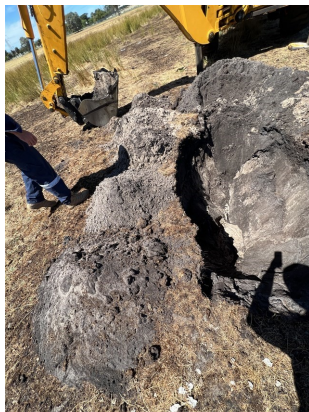
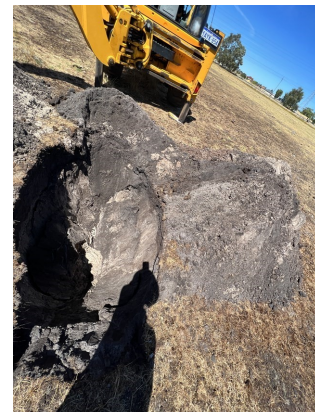
# TEST PIT LOG - TP04

Termination Reason: Refusal: Pit Wall Collapse

Remarks: Backfilled. Groundwater encountered at 0.8 m BGL.

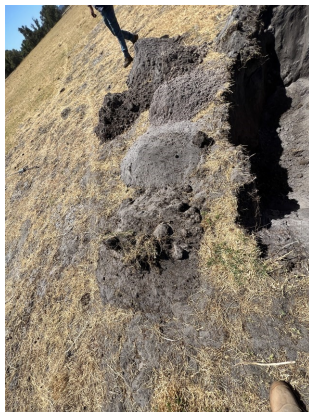
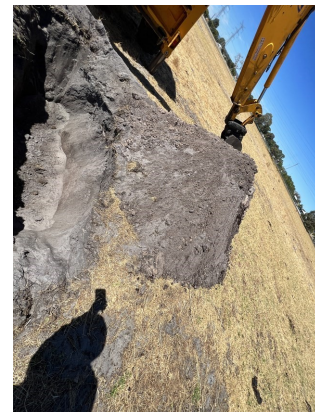
# TEST PIT LOG - TP05

Termination Reason: Refusal: Pit Wall Collapse

Remarks: Backfilled. Groundwater not encountered.

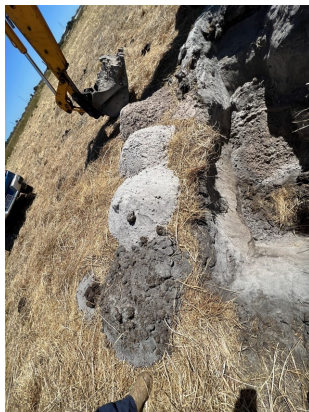
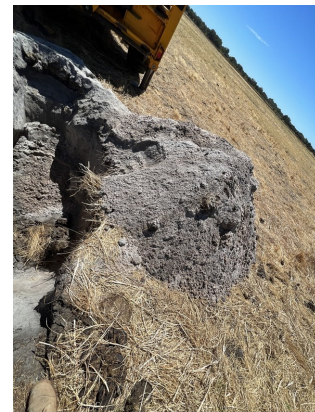
# TEST PIT LOG - TP06

Termination Reason: Refusal: Pit Wall Collapse

Remarks: Backfilled. Groundwater encountered at 1.5 m BGL.

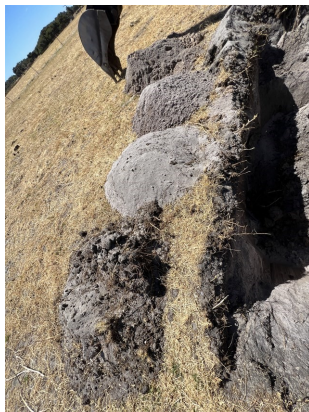
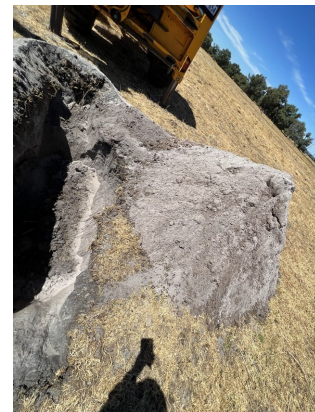
# TEST PIT LOG - TP07

Termination Reason: Refusal: Pit Wall Collapse

Remarks: Backfilled. Groundwater encountered at 1.8 m BGL.

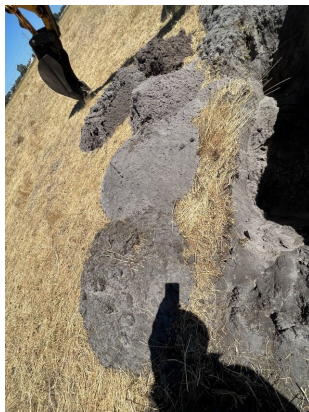
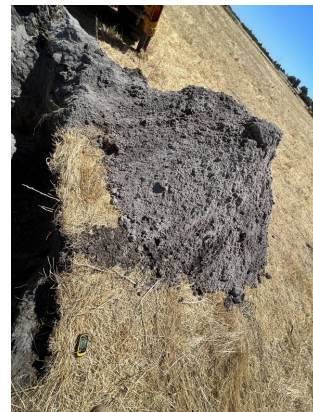
# TEST PIT LOG - TP08

Termination Reason: Refusal: Pit Wall Collapse

Remarks: Backfilled. Groundwater not encountered.

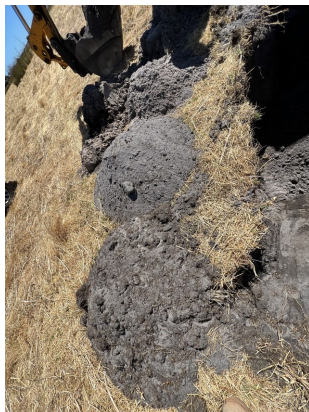
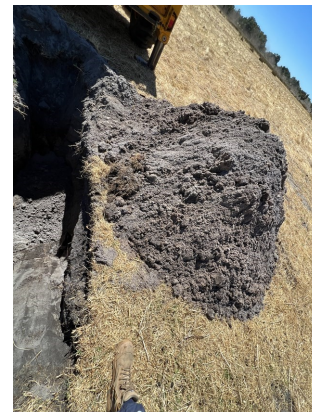
# TEST PIT LOG - TP09

Termination Reason: Refusal: Pit Wall Collapse  
 Remarks: Backfilled. Groundwater encountered at 1.3 m BGL.

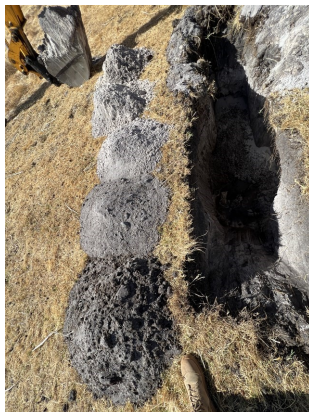
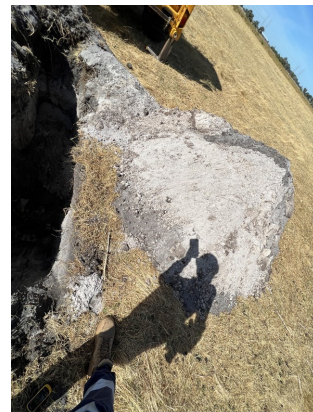
# TEST PIT LOG - TP10

Termination Reason: Refusal: Pit Wall Collapse

Remarks: Backfilled. Groundwater encountered at 1.4 m BGL.

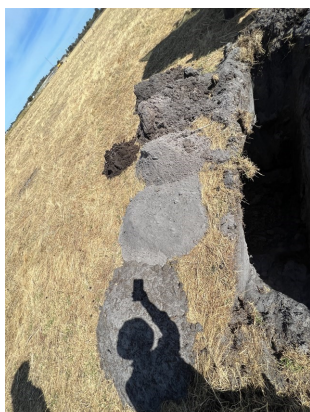
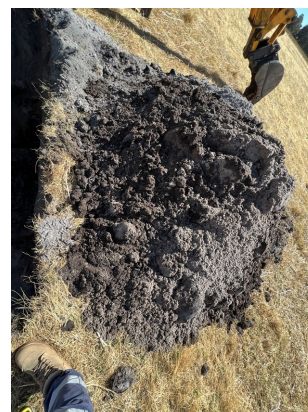
# TEST PIT LOG - TP11

Termination Reason: Refusal: Pit Wall Collapse

Remarks: Backfilled. Groundwater encountered at 1.3 m BGL.

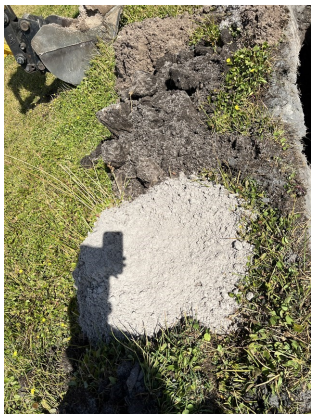
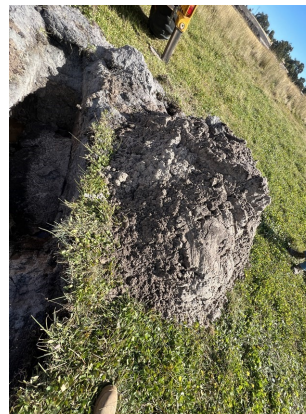
# TEST PIT LOG - TP12

Termination Reason: Refusal: Pit Wall Collapse

Remarks: Backfilled. Groundwater encountered at 0.8 m BGL.

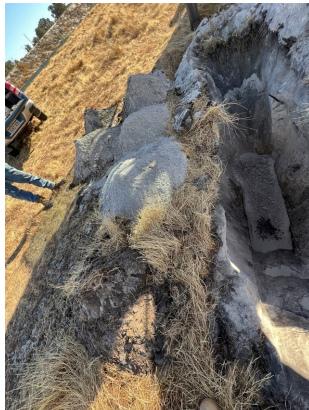
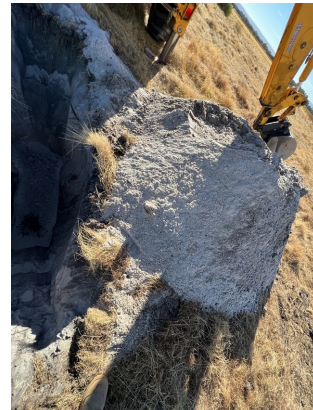
# TEST PIT LOG - TP13

Termination Reason: Refusal: Pit Wall Collapse  
 Remarks: Backfilled. Groundwater not encountered.

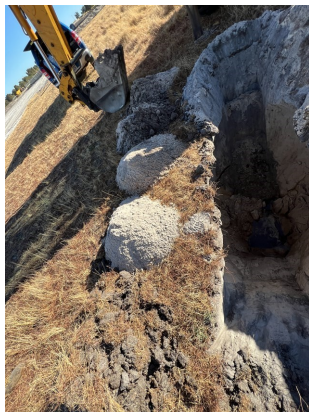
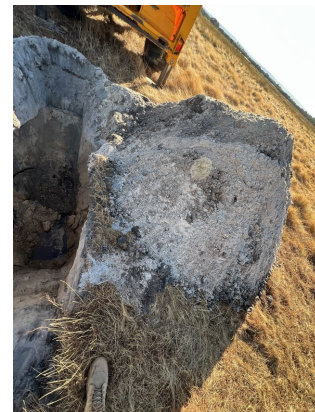
# TEST PIT LOG - TP14

Termination Reason: Refusal: Pit Wall Collapse

Remarks: Backfilled. Groundwater encountered at 1.6 m BGL.

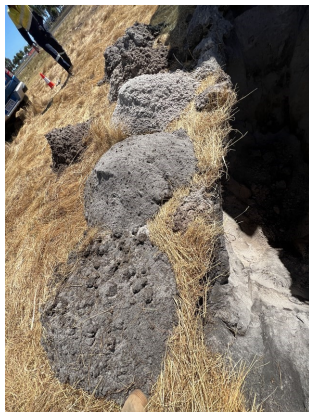
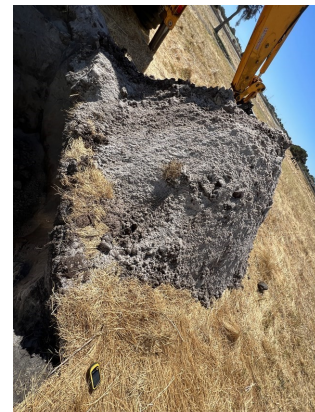
# TEST PIT LOG - TP15

Termination Reason: Refusal: Pit Wall Collapse

Remarks: Backfilled. Groundwater not encountered.

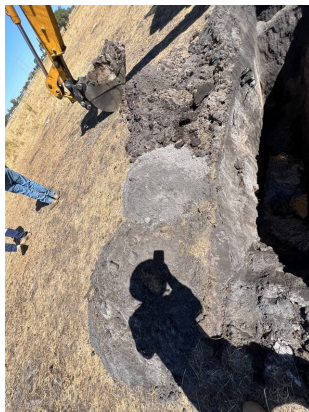
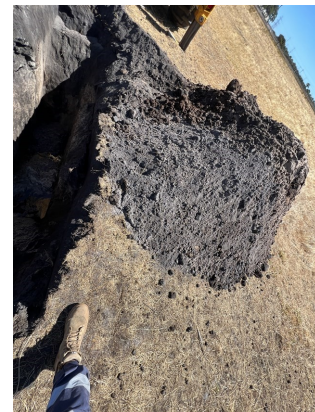
# TEST PIT LOG - TP16

Termination Reason: Refusal: Pit Wall Collapse

Remarks: Backfilled. Groundwater encountered at 1.3 m BGL.

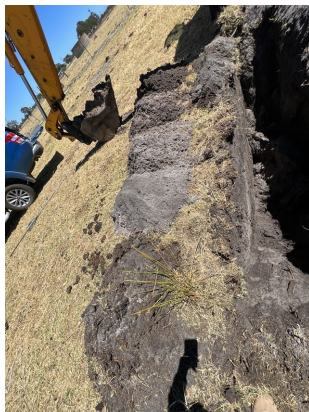
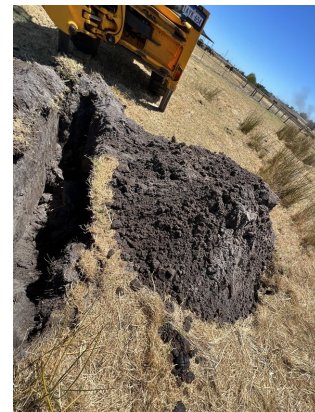
# TEST PIT LOG - TP17

Termination Reason: Refusal: Pit Wall Collapse

Remarks: Backfilled. Groundwater encountered at 1.7 m BGL.

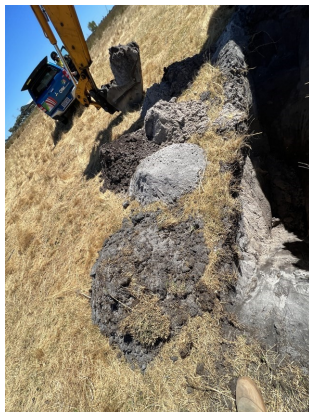
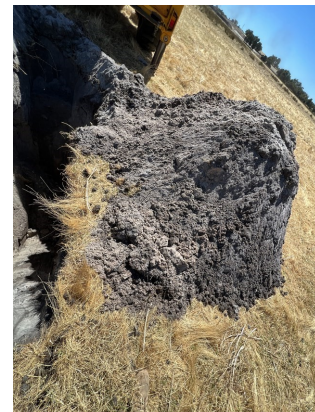
# TEST PIT LOG - TP18

Termination Reason: Refusal: Pit Wall Collapse

Remarks: Backfilled. Groundwater encountered at 1.6 m BGL.

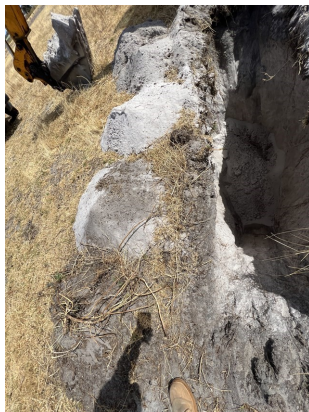
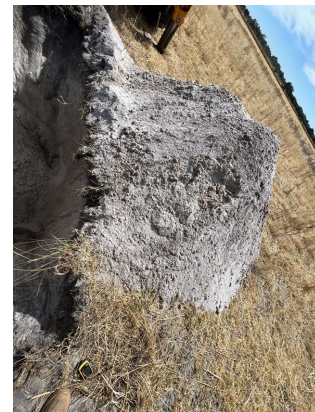
# TEST PIT LOG - TP19

Termination Reason: Refusal: Pit Wall Collapse

Remarks: Backfilled. Groundwater not encountered.
