Appendix G: Tree Retention and Replacement Strategy

Byford Rail Extension Tree Canopy Vision and Strategy

The Tree Retention Strategy (the 'strategy') has been developed as a best practice document to guide tree retention for the duration of the project.

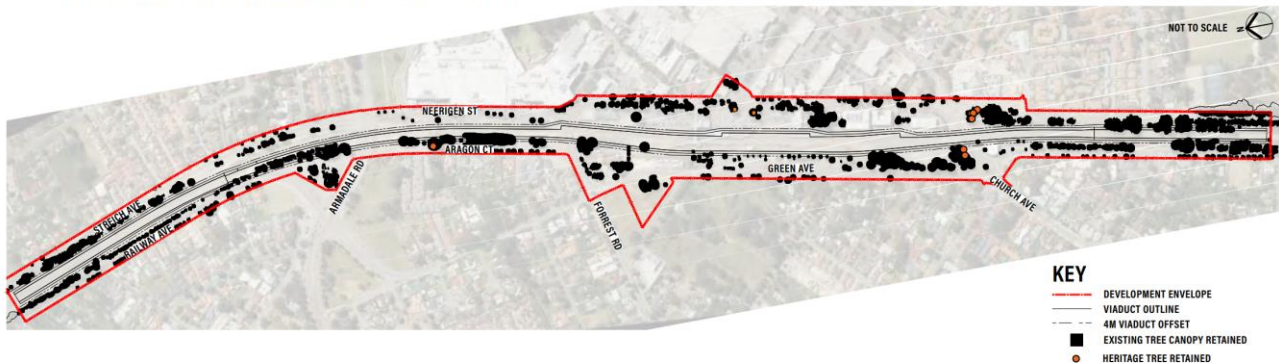
A canopy mapping existing was undertaken to develop baseline canopy data. The existing canopy pre-development is:
~43,880 M² OF CANOPY
~18.78% CANOPY COVERAGE WITHIN DEVELOPMENT ENVELOPE

Figure 3: Baseline canopy indicating the existing (pre-development) tree canopy as a percentage of the development envelope.

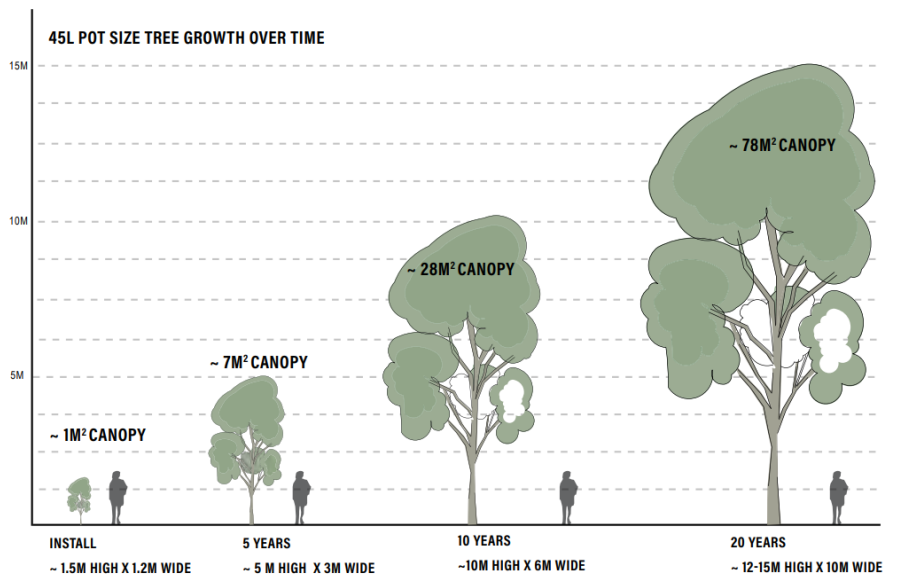
The projected average growth of the proposed tree species was based upon the personal observations by the Project Arborist and Landscape Architect of average tree growth of various species in similar conditions (refer to Figure 6 as example for 45L). A number of likely canopy projections have been modelled at day 1; year 5; year 10; and year 20 to establish. For consistency in the modelling, it has been assumed that the existing tree canopy is unchanged during the modelling period.

Figure 6: Project average growth of a 45L tree over time used for canopy modelling projects.

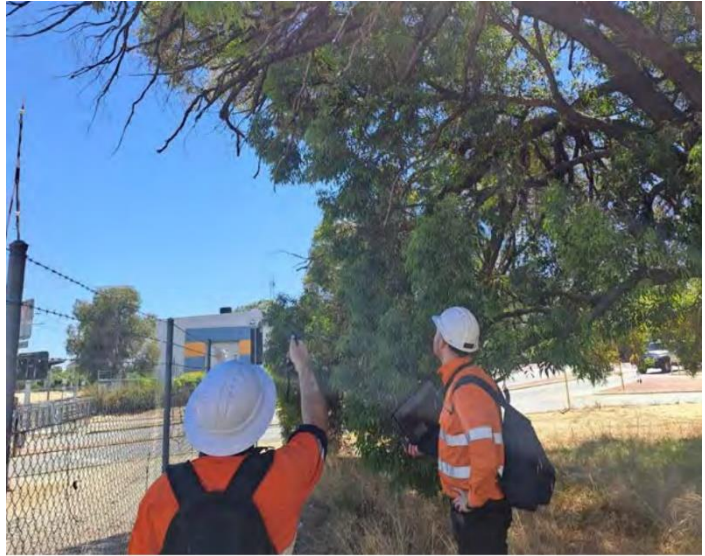
Figure 7: Project Arborist reviewing pruning requirements with Construction team.

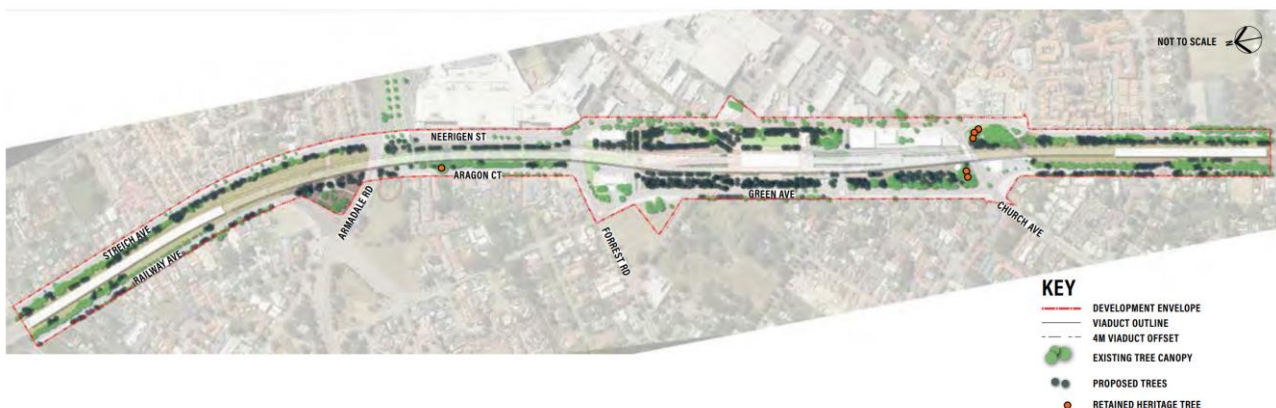
- ~ 76,036M² PROJECTED CANOPY
- ~ 32.18% PROJECTED CANOPY

Figure 8: Tree canopy projection at Year 20 indicating approximately 32% canopy cover.

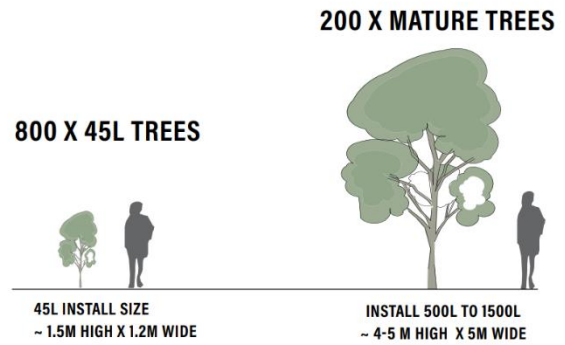
Figure 9: Proposed numbers and sizing of trees to be installed.

- 65% of existing canopy likely to be installed.
- 1000 trees to be installed (refer to Fig 9).
- All Heritage trees to be retained.
- Exceed the current baseline canopy within approximately +5 years; and;
- Exceed 30% tree canopy by Year 20.

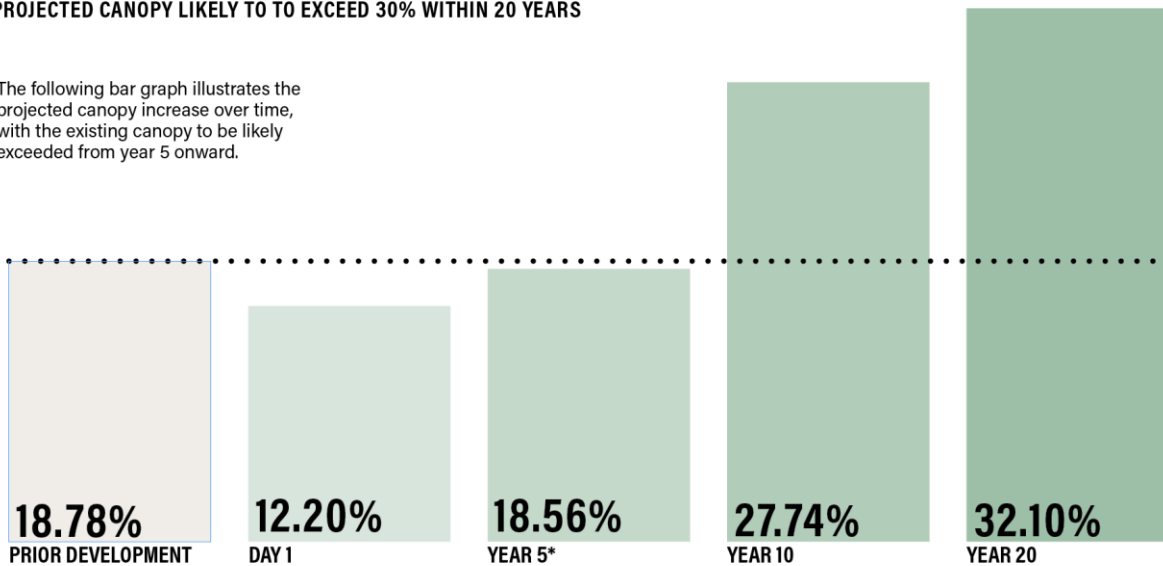
The following bar graph illustrates the projected canopy increase over time, with the existing canopy to be likely exceeded from year 5 onward.

***ALL NUMBERS ARE INDICATIVE ONLY BASED ON CANOPY MODELLING**

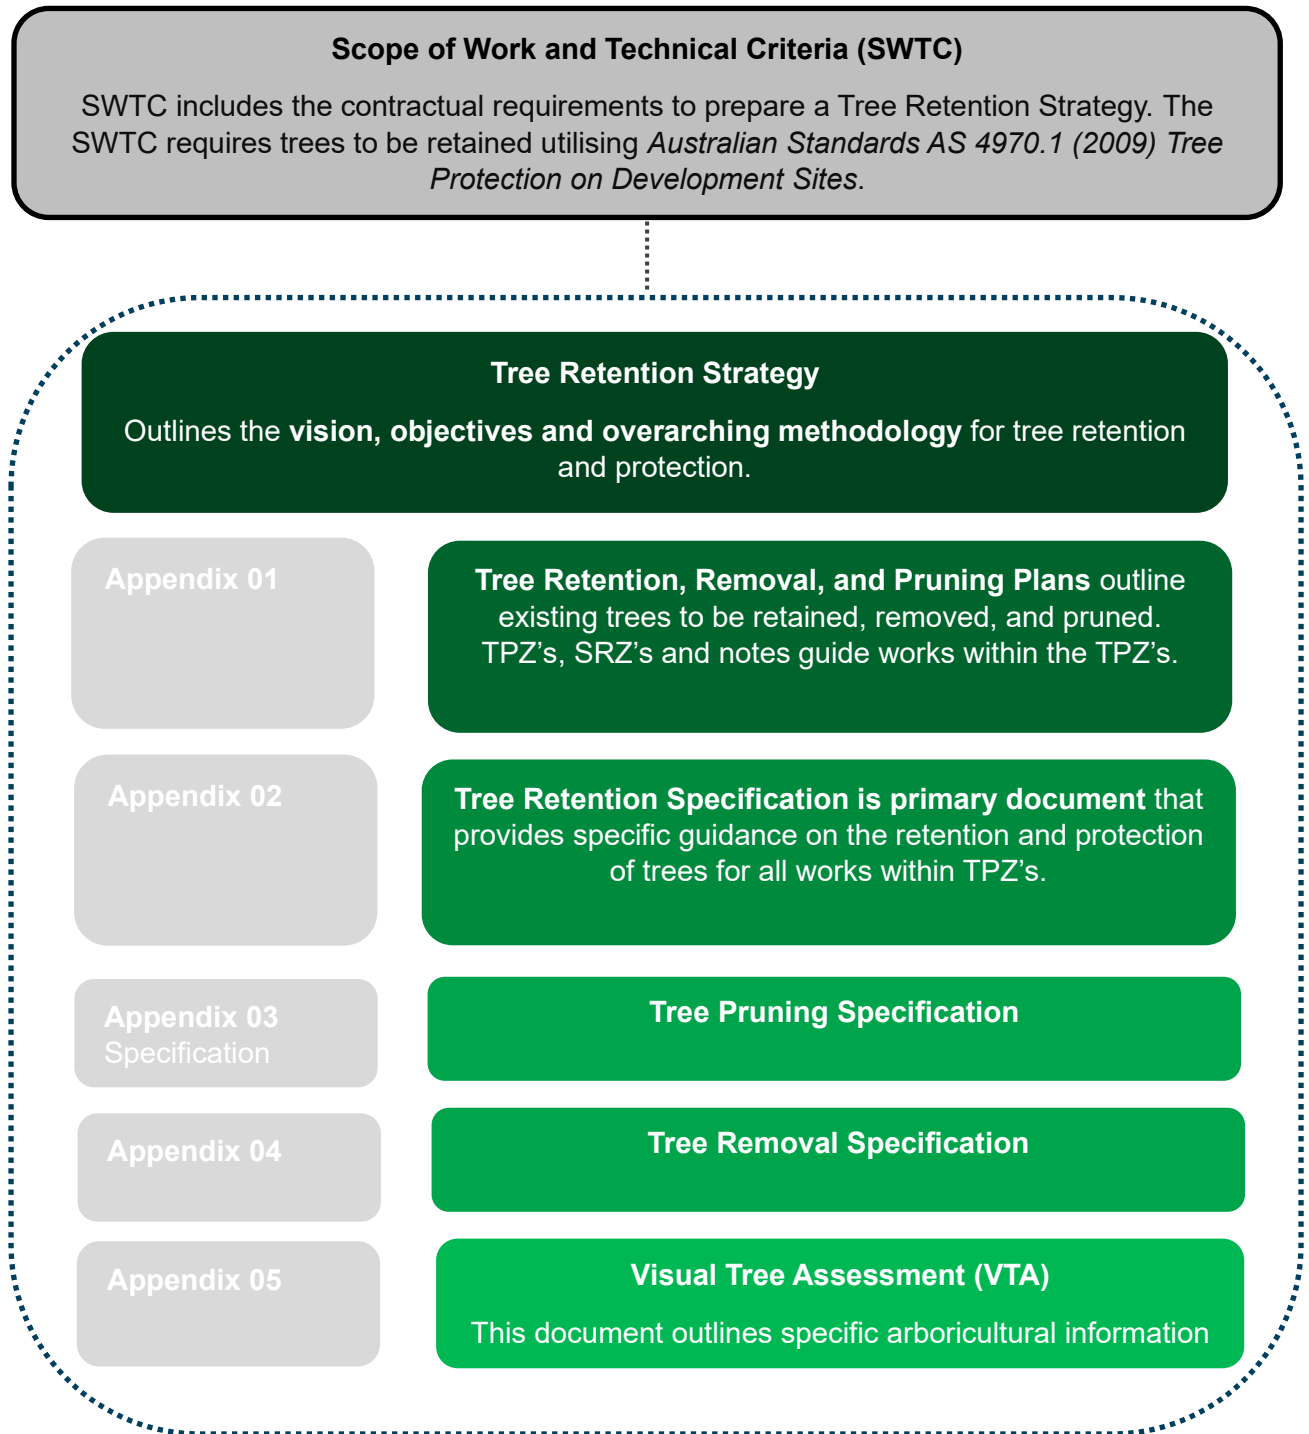
The SWTC outlines the requirement to develop a Tree Retention Strategy and to retain trees in accordance with AS 4970.1 (2009). This diagram illustrates the relationship of the strategy to the SWTC and AS 4970.1 documents and other key documents and specifications as companion documents that will support the strategies implementation.

Figure 13: Structure of the document.

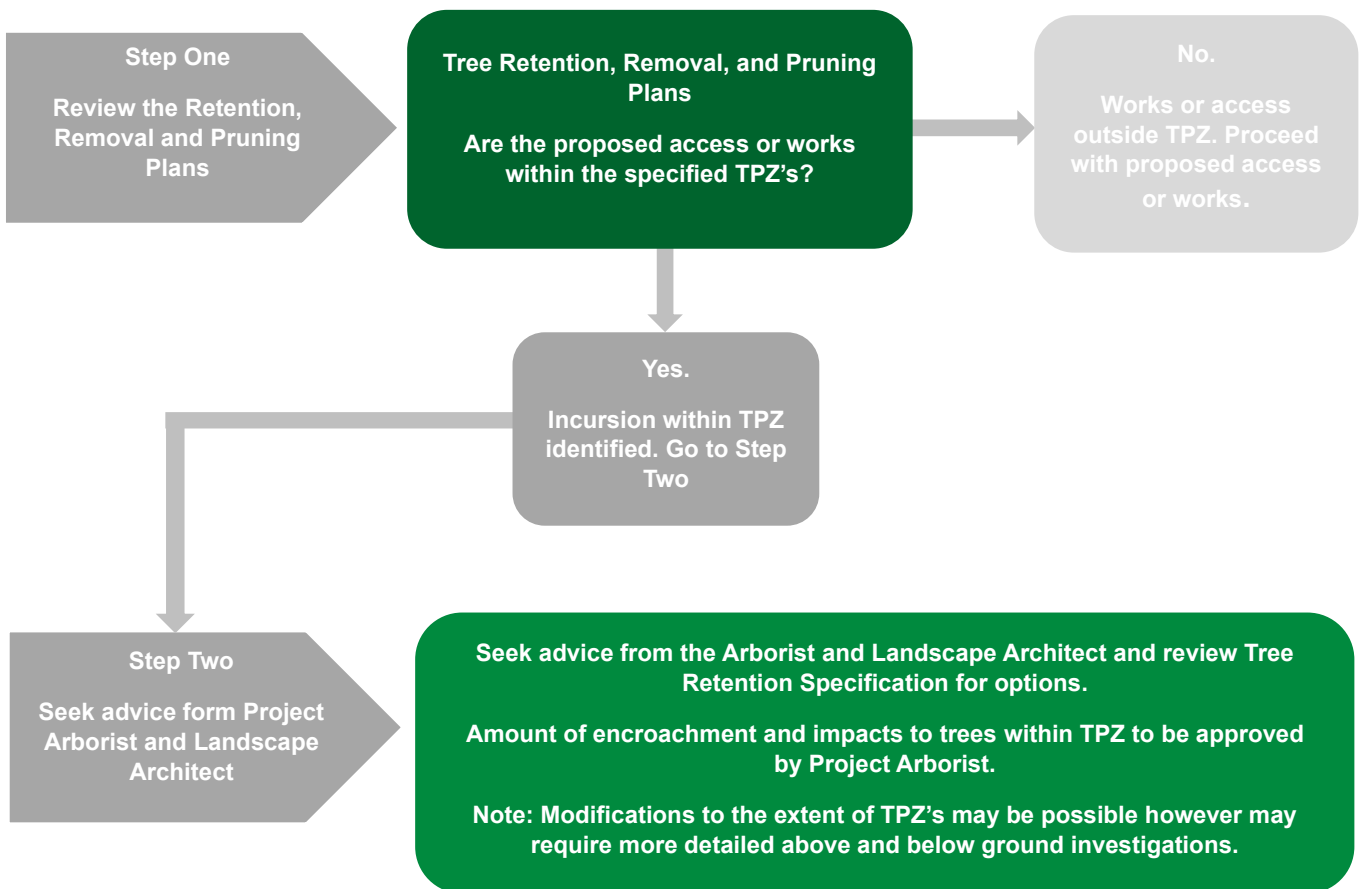
Upon reviewing the strategy all consultants and contractors shall follow the process outlined below:

Figure 12: Tree Retention Methodology

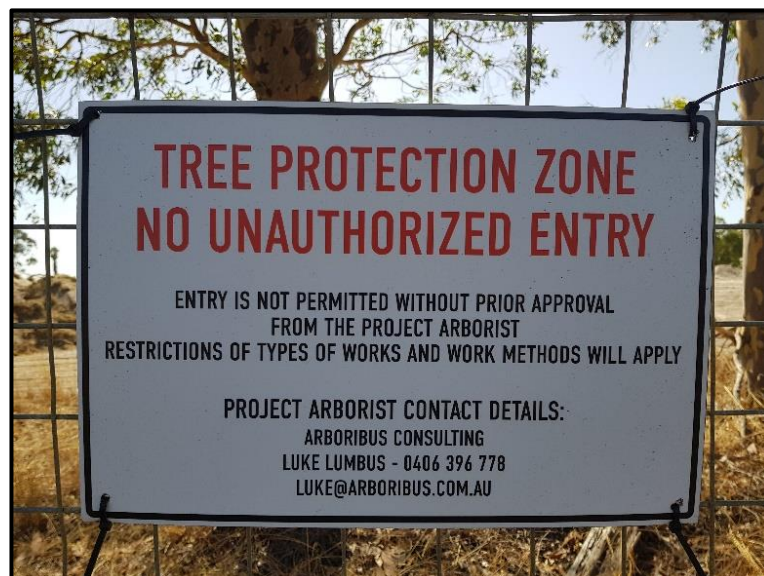
- TPZ Fencing is to have signage installed that identifies the TPZ as a protected area and that no access is permitted without prior approval from the nominated AQF level 5 Arborist. TPZ signs are to clearly display the Nominated AQF level 5 Arborist name, mobile number and email address (refer figure 3 below for example TPZ signage).

Figure 3. Example of TPZ Signage. Image source Arboribus Consulting 2022

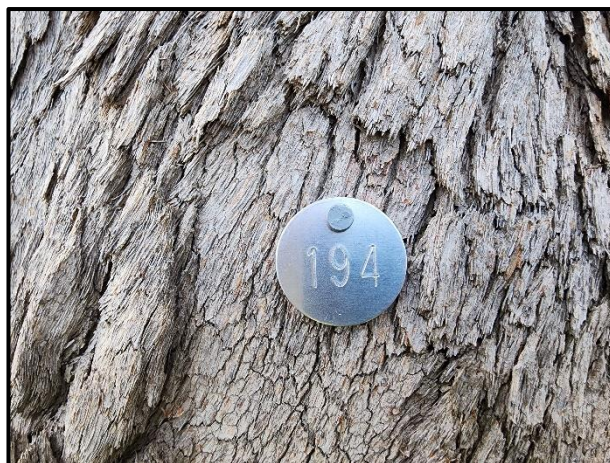
- All Trees identified for retention or removal for the Armadale Station Precinct construction, have round, individually numbered tree tags installed approx. 1.5 meters from ground level (where possible) on main stems - refer figure 4 below. Where trees have Tags missing or vandalised, no works are to proceed to the tree and the contractor is to continue working in other areas until a response on how to proceed is provided from UDLA & Arboribus (in collaboration with the MetConnx Environmental Manager).
- No further trees shall be pruned without prior approval from UDLA/Arboribus (in collaboration with the MetConnx Environmental Manager).

Figure 4. Image showing metal tree tag and numbering of the identified trees installed approx. 1.5 meters from ground level where possible

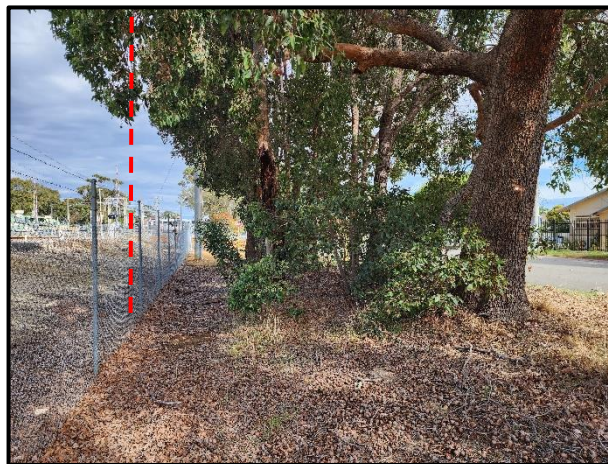
Figure 5. Image showing pegged pruning alignments at Aragon Ct as specified by MetCONNx and estimated pruning alignment (red dashed line) for construction purposes.

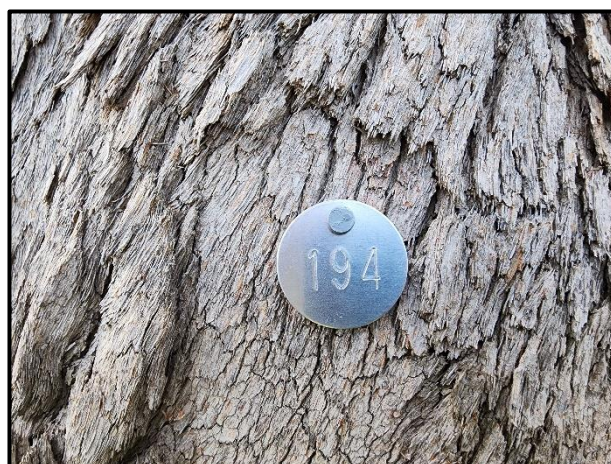
- All Trees identified for retention or removal for the Armadale Precinct & Viaduct Extents construction, have round, individually numbered tree tags installed approx. 1.5 meters from ground level (where possible) on main stems - refer figure 4 below. Where trees have Tags missing or vandalised, no works are to proceed to the tree and the contractor is to continue working in other areas until a response on how to proceed is provided from UDLA/Arboribus.
- No further trees shall be removed without prior approval from UDLA & Arboribus (in collaboration with the MetConnx Environmental Manager).

Figure 4. Image showing metal tree tag and numbering of the identified trees installed approx. 1.5 meters from ground level (where possible)

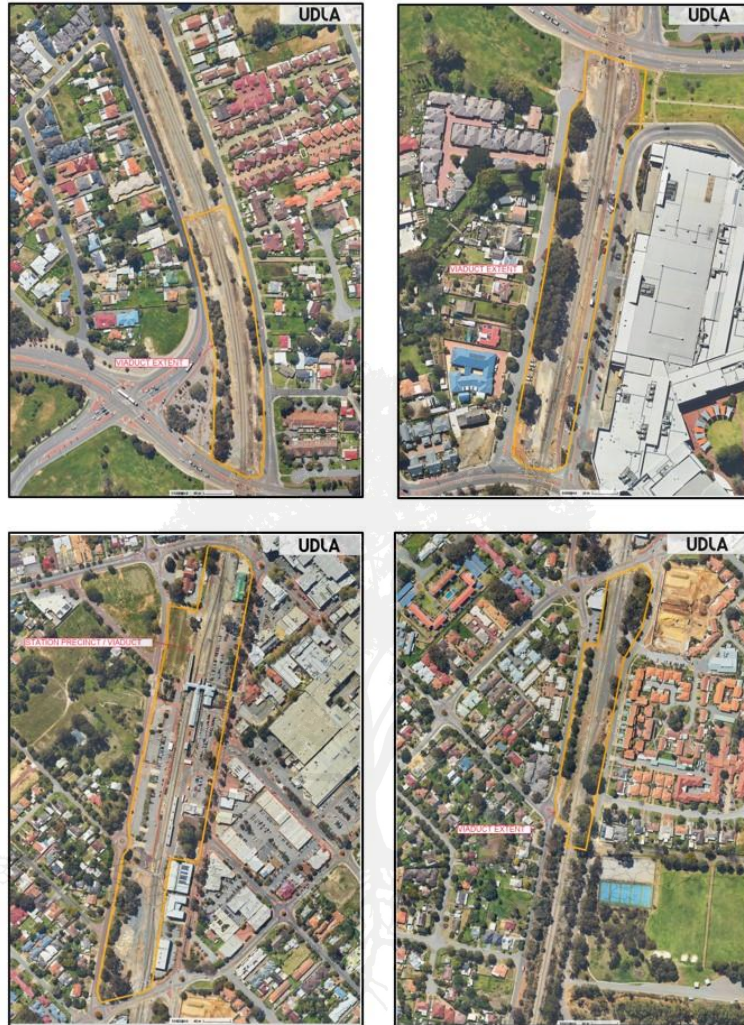
Figure 1. Area of assessment specified by UDLA (outlined yellow).
Aerial image source UDLA- Date supplied - 27 April 2022

- To inspect the trees within the areas specified by UDLA (outlined in Figure 1) and provide comment regarding tree status and; identify preliminary tree protection considerations to be further developed as part of the proposed MetroNet Armadale Station Precinct development.

- At the request of Mike Harris (Associate Landscape Architect at UDLA), Arboribus Consulting has been engaged to assess: all City of Armadale Street trees; trees with trunk diameter greater than 400 mm within the Rail corridor and large groups of trees within the area specified within Figure 1, and provide the following information:

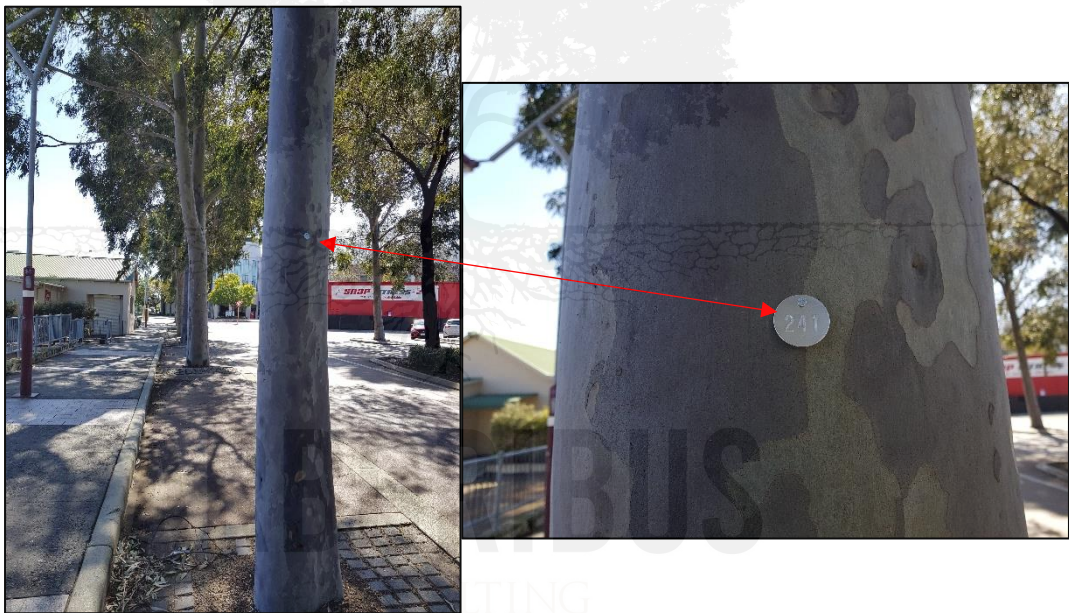
Figure 2. Showing metal tree tag and numbering of the identified trees installed approx. 1.5 meters from ground level

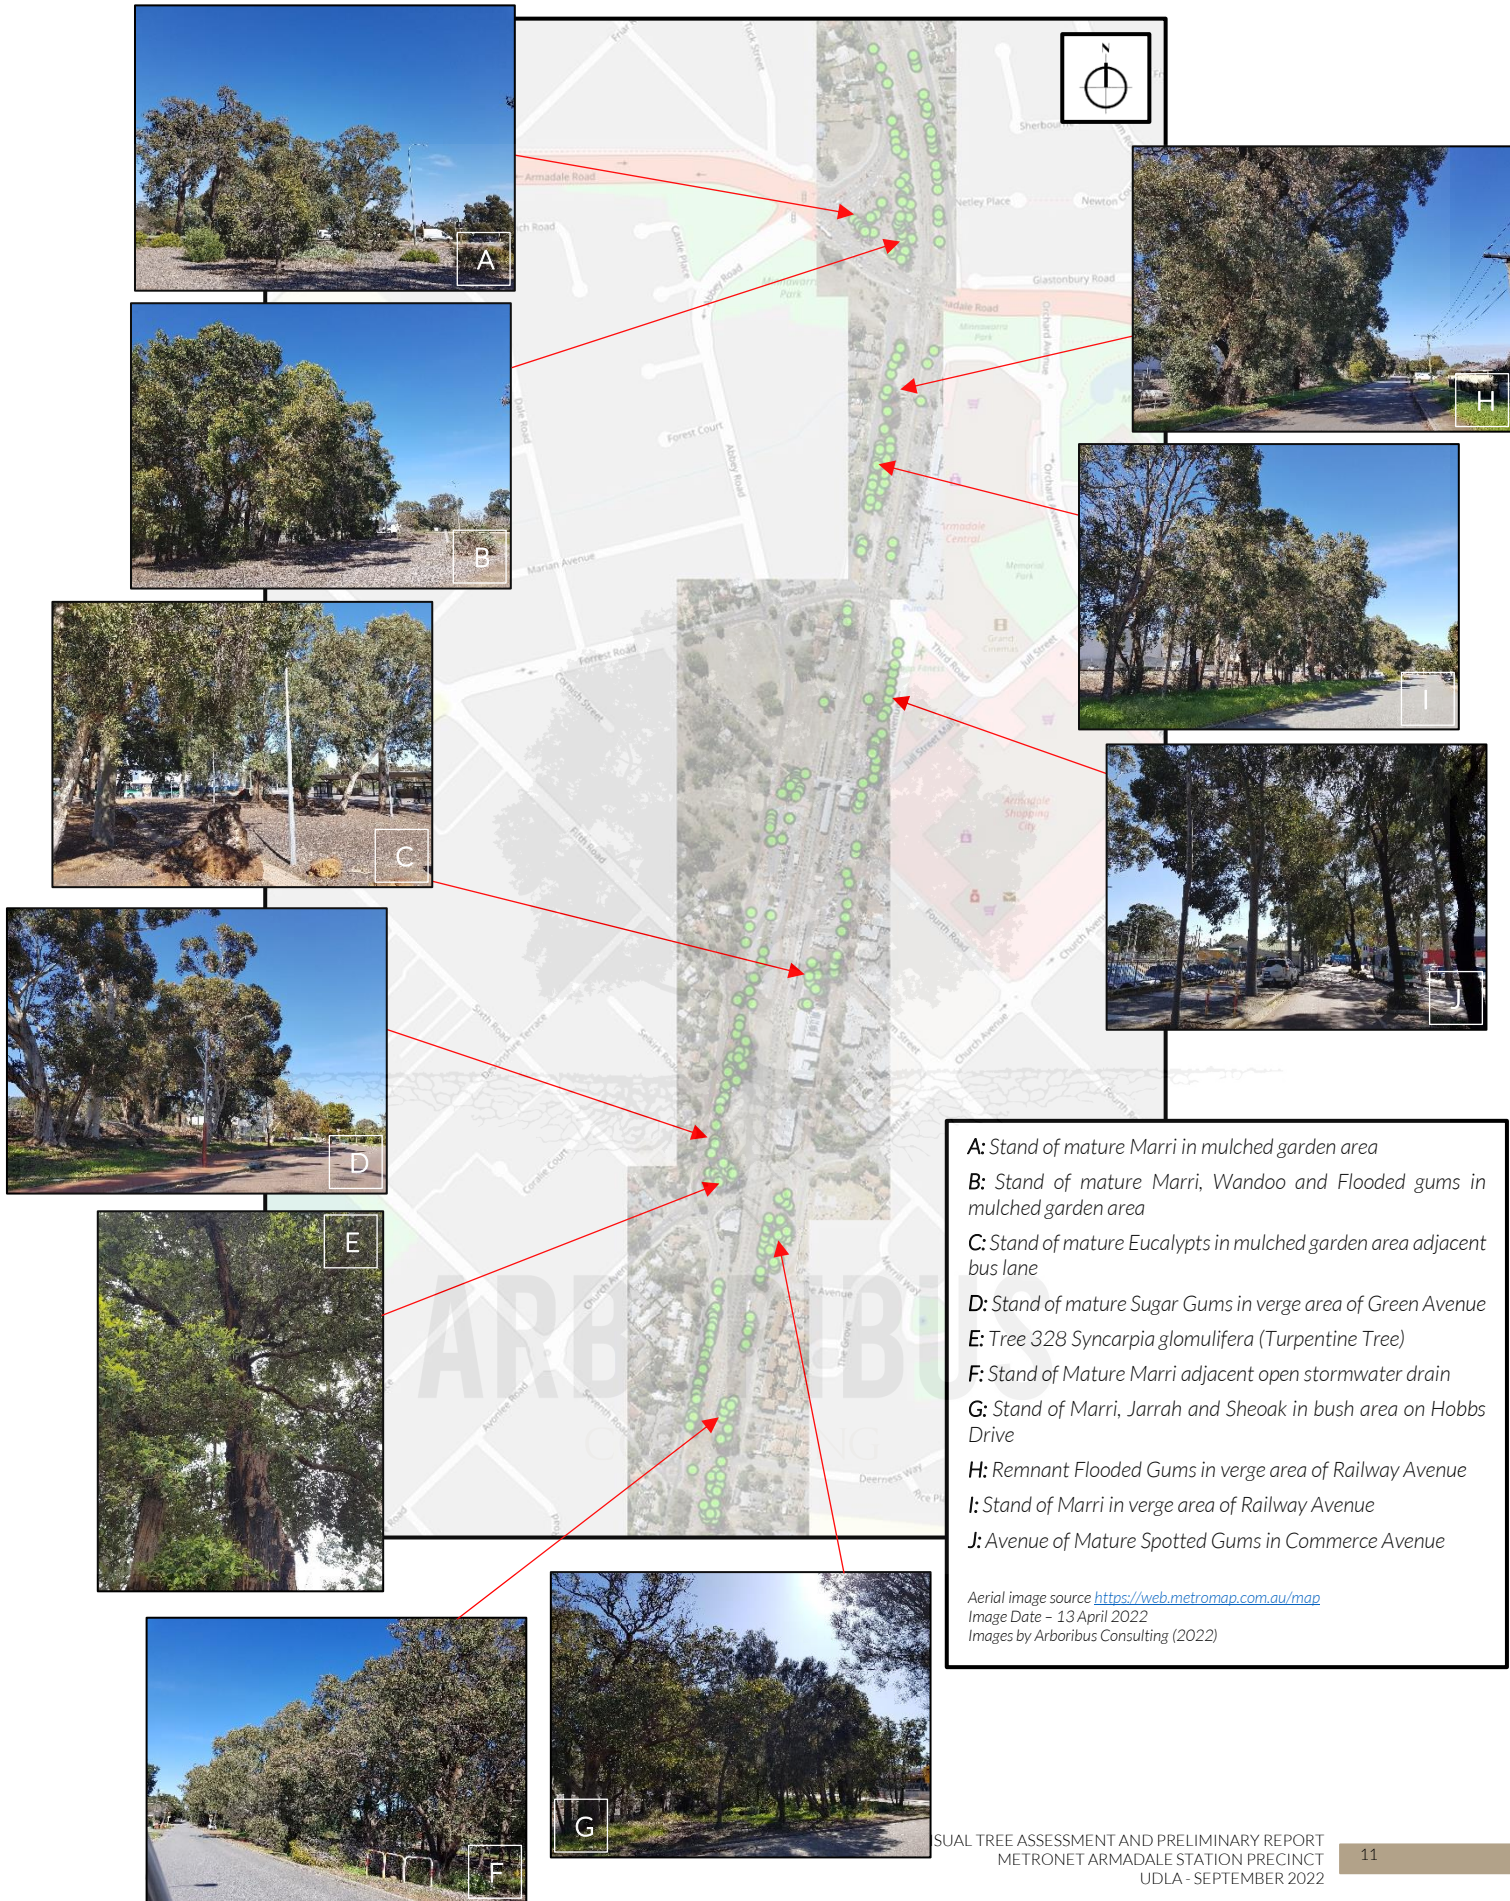
A: Stand of mature Marri in mulched garden area
B: Stand of mature Marri, Wandoo and Flooded gums in mulched garden area
C: Stand of mature Eucalypts in mulched garden area adjacent bus lane
D: Stand of mature Sugar Gums in verge area of Green Avenue
E: Tree 328 *Syncarpia glomulifera* (Turpentine Tree)
F: Stand of Mature Marri adjacent open stormwater drain
G: Stand of Marri, Jarrah and Sheoak in bush area on Hobbs Drive
H: Remnant Flooded Gums in verge area of Railway Avenue
I: Stand of Marri in verge area of Railway Avenue
J: Avenue of Mature Spotted Gums in Commerce Avenue

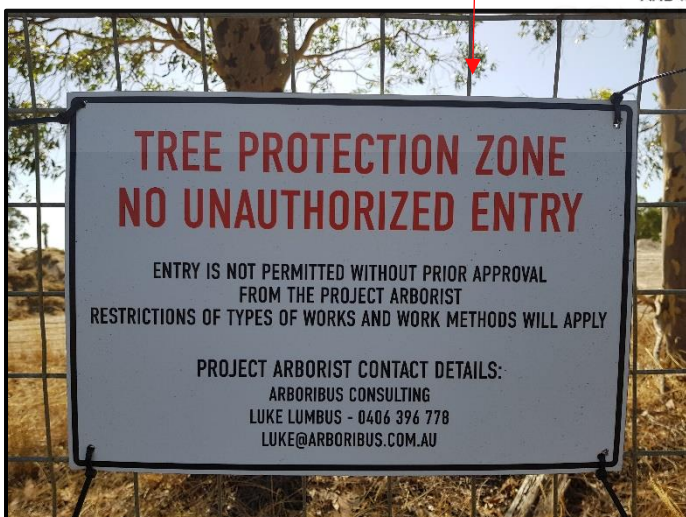
TREE PROTECTION ZONE FENCING

TO BE IMPLEMENTED FOR TREES IDENTIFIED FOR RETENTION AND MAINTAINED FOR THE DURATION OF WORKS.
