STRUCTURAL CONDITION ASSESSMENT 2023

10 MCKAY STREET, PORT HEDLAND, WESTERN AUSTRALIA

REV	DATE	DESCRIPTION	ORIG	CHK	APPR
0	3-March-23	Issued for AIE Review	MR	NVT	KB
Document Number	AU23-030-05-001_1 - 10 McKay Street Port Hedland.docx	Total No. Pages Including Cover Sheet	29

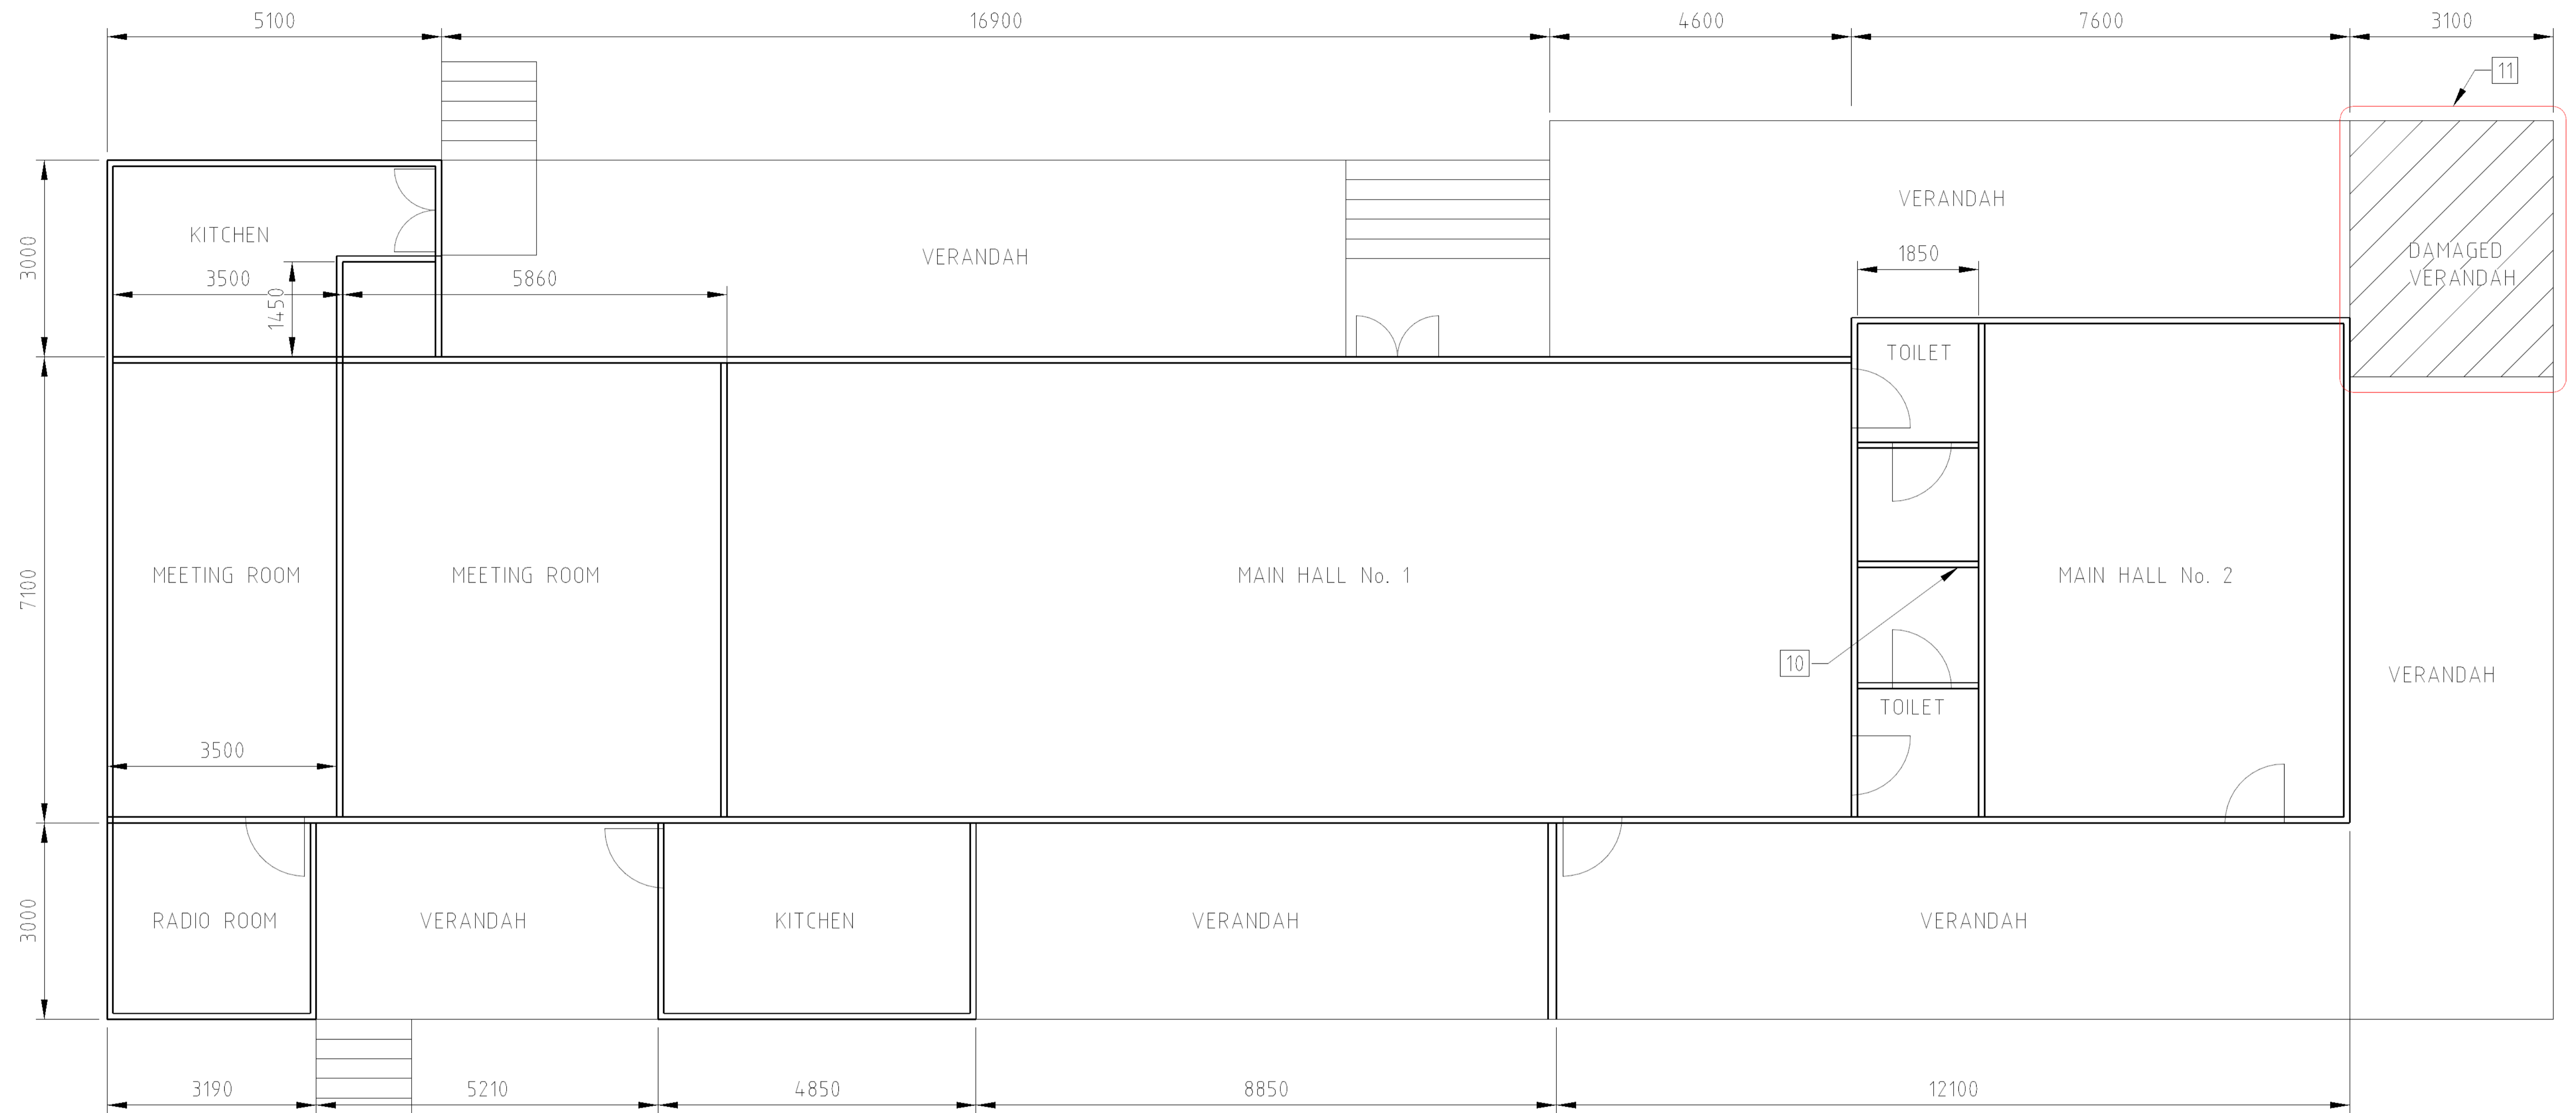
10 MCKAY STREET PORT HEDLAND STRUCTURAL INSPECTION CONDITION ASSESSMENT 2020 FOUNDATION LAYOUT			
SCALE	A3	DRAWING NUMBER	REV
1:100		AU23-039-06-001	A

- *Northern end of the building (Port Hedland Gamefishing Club end - Gridline 9 to 29 on drawing AU23-039-06-001 in Appendix A): **Extremely High Risk*** for structural integrity failure. Rectification works are highly recommended prior to building use.

- *Southern end of the building (VMR Operation End - Gridline 1 to 9 on drawing AU23-039-06-001 in Appendix A): **High Risk*** for structural integrity failure. Rectification works are recommended within the next 3 to 6 months. It should be considered that further deterioration or failure of the Northern end of the building can cause further damage to the Southern end given the two sections having the same roof, walls, and floor structures.
